Property Flood Resilience

Stories from homes and businesses who have made adaptations
to help them recover more quickly after a flood

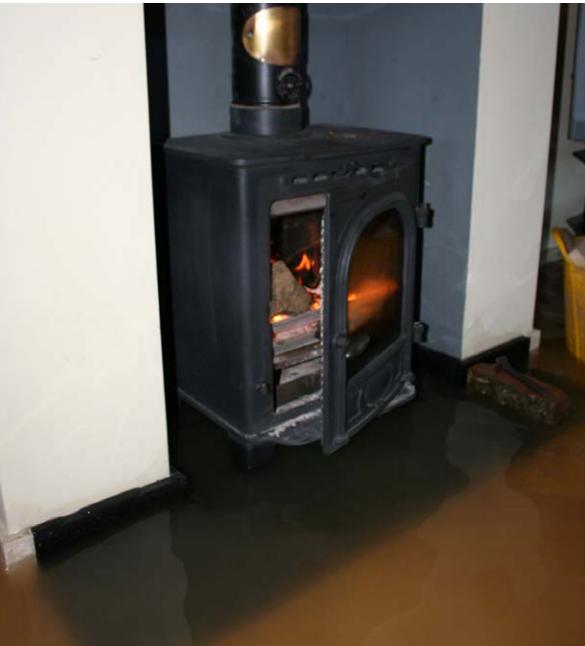
Immediately light the log burning stoves helps start the drying process and reduces the time it takes to recover.

Once the water starts to drop, a pond vacuum is used to pump water from the house, as this helps with the removal of silt, and the drying process can commence. They have bought two large dehumidifiers to get the drying process started immediately and they light their two log burning stoves. This significantly reduces the time it takes to recover.

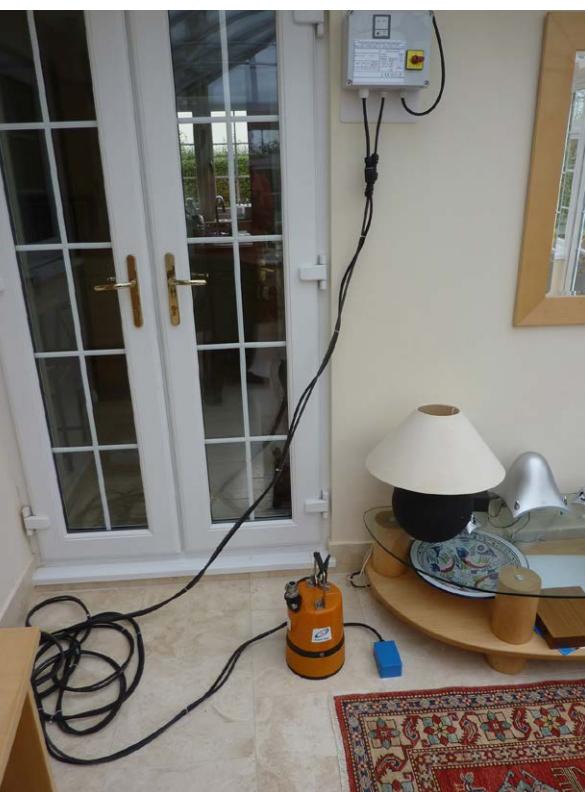
Electrics installed up high, which come down from the floor above, enabling them to run powerful puddle pumps.

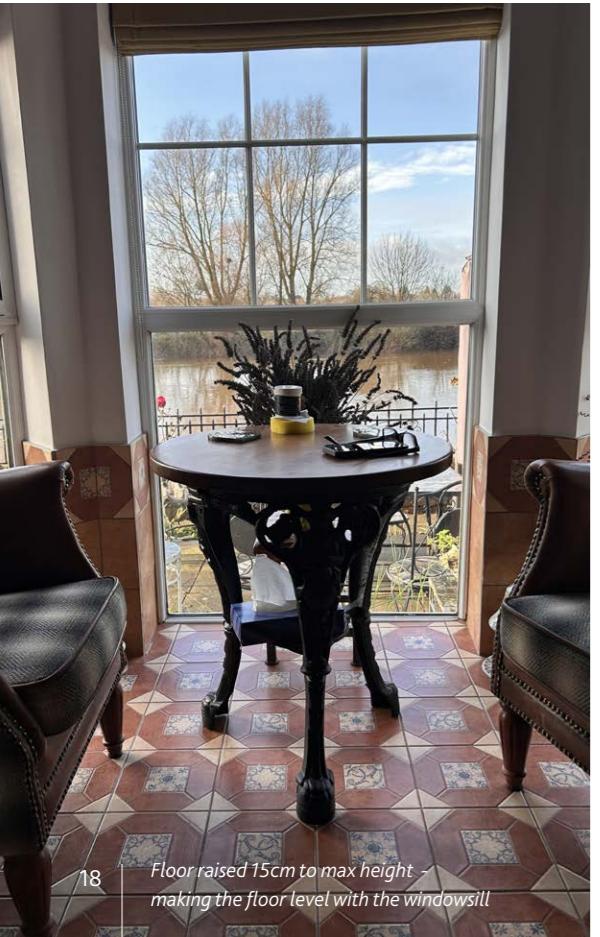
Floor raised 15cm to max height - making the floor level with the windowsill

- Remove inner wall and stairs
- Seal all gaps around floors/wall with waterproof cement, add joint fillet.
- Waterproof tanking (Koster) applied to floor/walls
- Floor raised 15cm to max height - making the floor level with the windowsill
- Replace pendant lights with downlights, due to the loss of head height in the room
- Waterproof tanking second layer to floor/ walls
- Epoxy based liquid waterproof membrane
- Tiling floor/lower walls, including slight inclines on floor towards pump wells
- New raised kitchen installed on stainless steel legs
- New open-plan stairs, raised on a plinth.
- Installation of hose points to front exterior and interior
- Installation of Sump & Pump areas front/ rear, with permanent pump placement/ outlet.

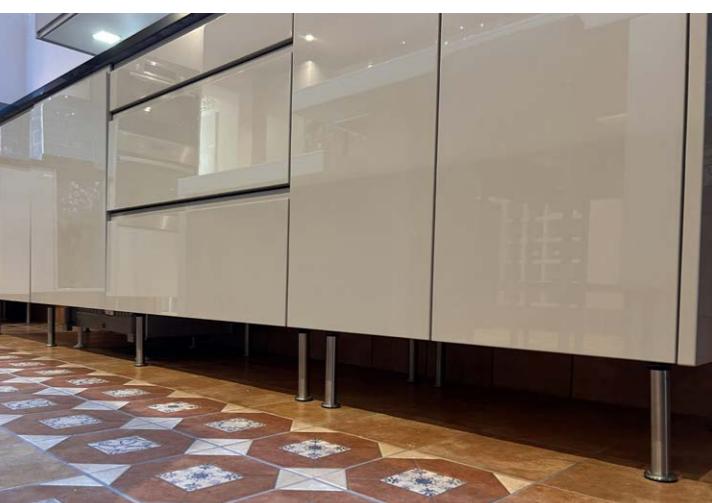
New raised kitchen installed on stainless steel legs.

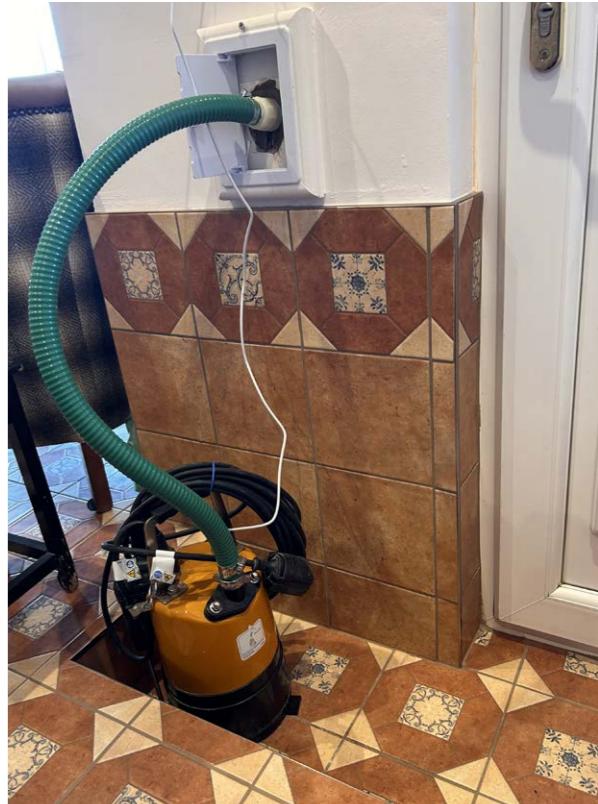
Permanent sump pump all set up and ready to go.

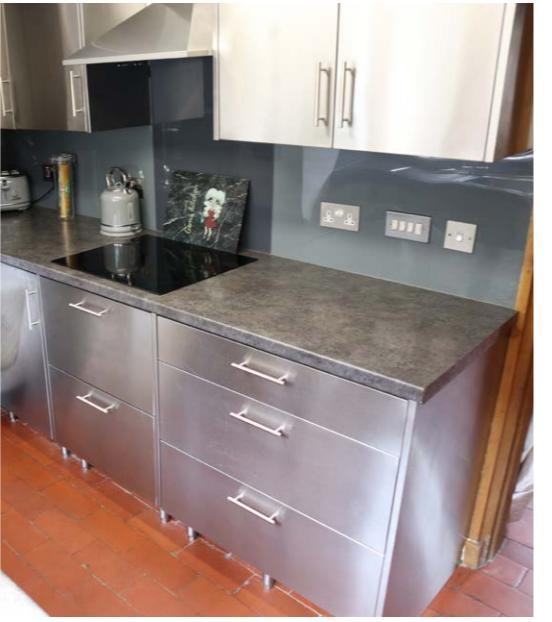
Stainless-steel kitchen and solid floor with quarry tiles.

- Solid floor with quarry tiles.
- Cement render to the walls.
- Plug sockets are raised.
- Fitted plastic skirting boards.
- Non return valves to outlet pipes.
- Three powerful puddle pumps.
- A grant part-funded a stainless-steel kitchen.

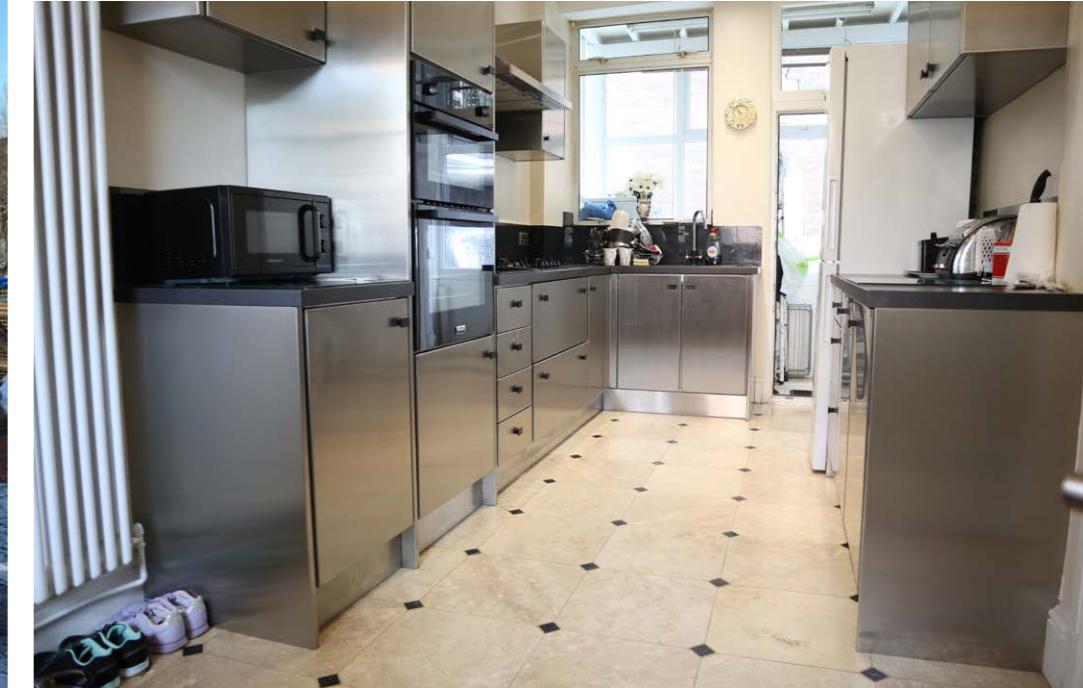
Tiled kitchen floor and stainless-steel kitchen.

- Fitted a stainless-steel kitchen with integral cooker.
- Built a balcony above where they park their cars to enable them to safely watch the river rise and provide them with a place to evacuate from if the occasion arose. It also doubles up as somewhere to sit and enjoy the river in the summer.

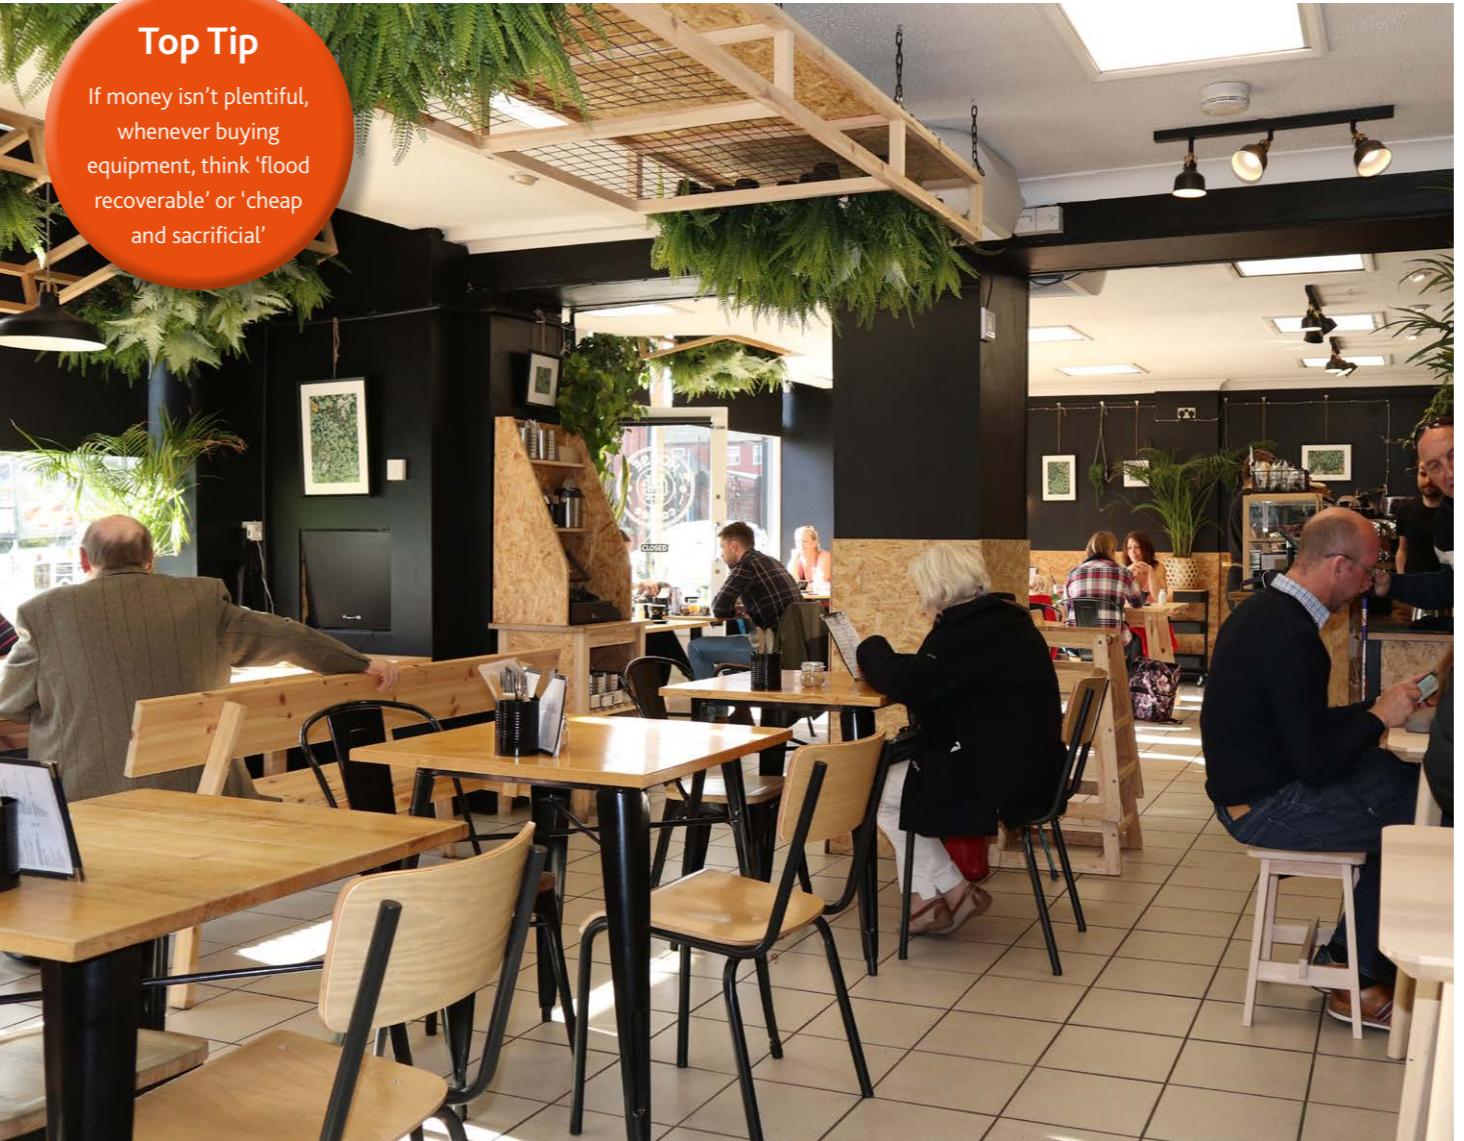
OSB boarding pinned to the wall can easily be removed and replaced to allow the walls behind to dry out.

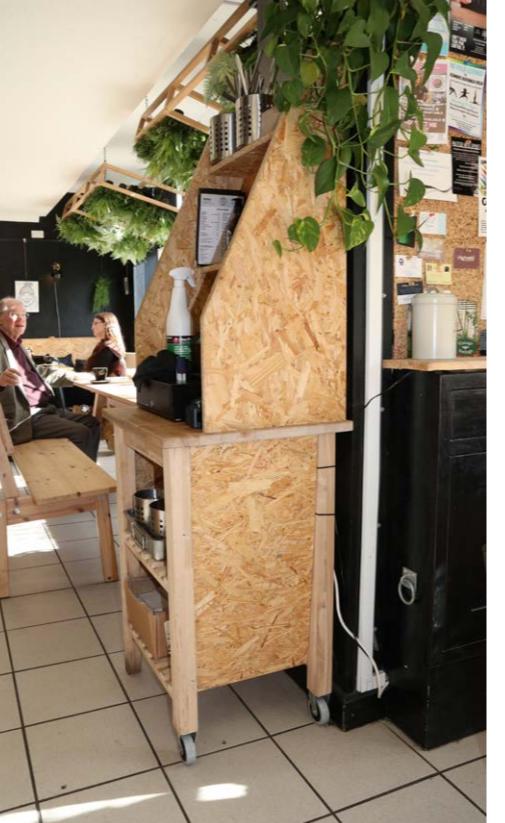
Some units are on casters so they can be easily moved.

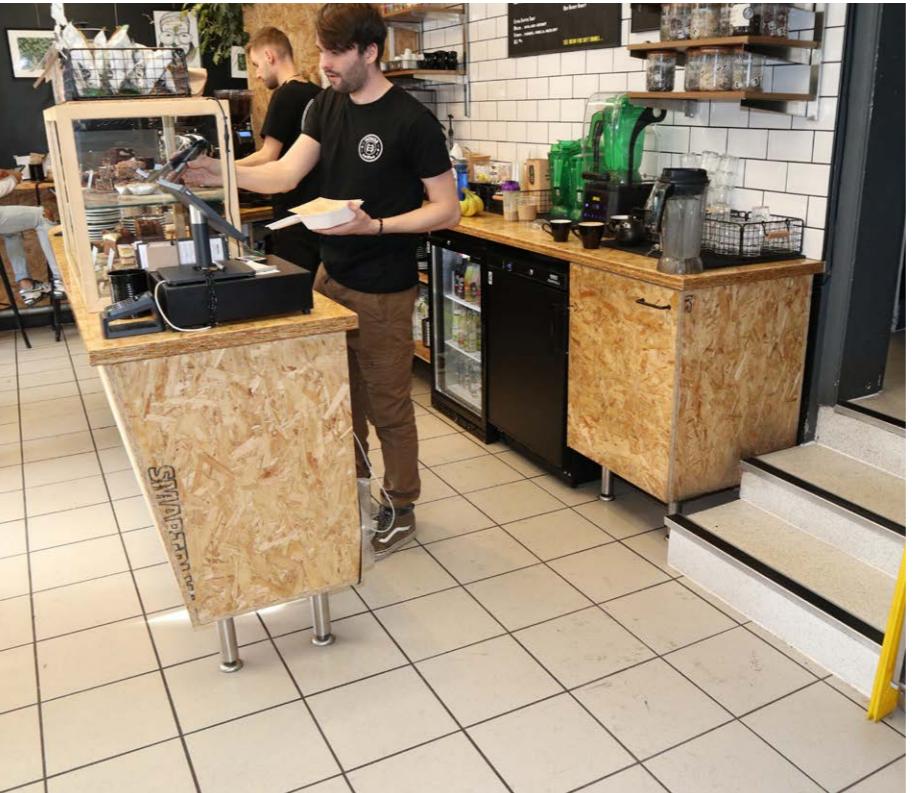
The shop counter is made of an inexpensive material with stainless-steel legs, which can be easily moved.

- Acquiring tables and chairs with metal legs.
- The shop counter is made of an inexpensive material and has high stainless-steel legs, which can be easily dismantled and moved if a significant flood is expected.
- Tiled flooring, which can be easily washed down and sanitised.
- After drying the original plaster, OSB boarding has been added, which is an engineered wood which is fairly water resistant. The OSB boarding is pinned to the wall, so it can easily be removed and replaced and allows the walls behind to dry out if needed. It also gives the coffee shop an 'industrial chic' look and looks totally deliberate.
- Using a government grant, the couple now have kitemarked flood barriers to both doors and submersible pumps just inside the doors, which pump away any ground water or any flood water that has got into the shop.

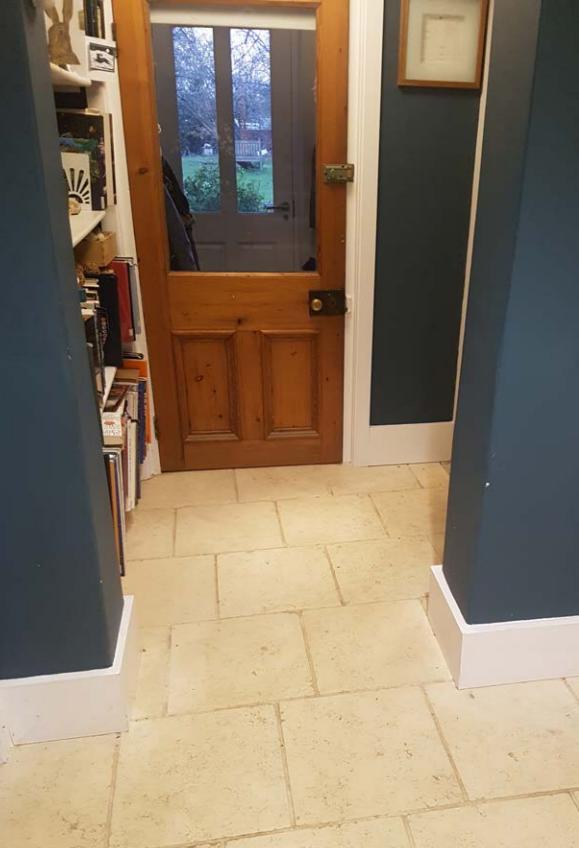
Sacrificial chain-store bookcases with sturdy frames are turned on their sides to support other furniture above flood level.

- Sacrificial chain-store bookcases with sturdy frames are turned on their sides to support other (more valuable) furniture above flood level (then shelves replaced); this method worked well for 2 weeks during a previous flood.

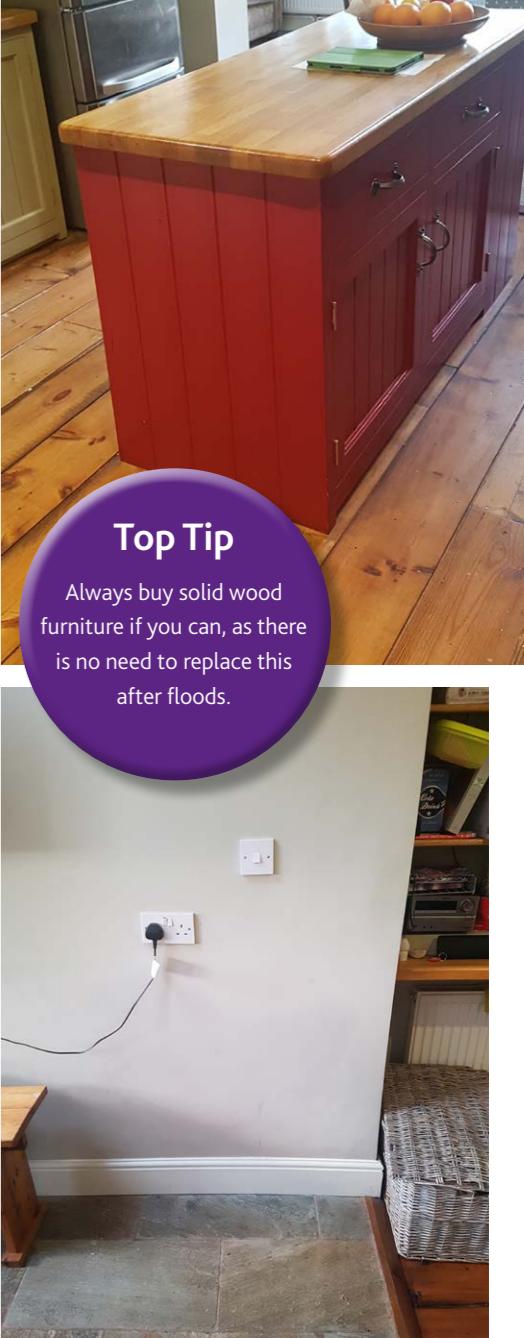
All electric service points are raised above flood level.

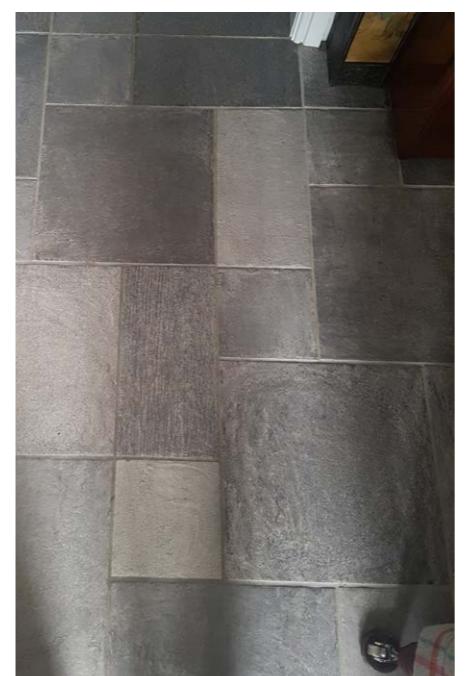
Tiling in the ground floor above insulation and underfloor heating.

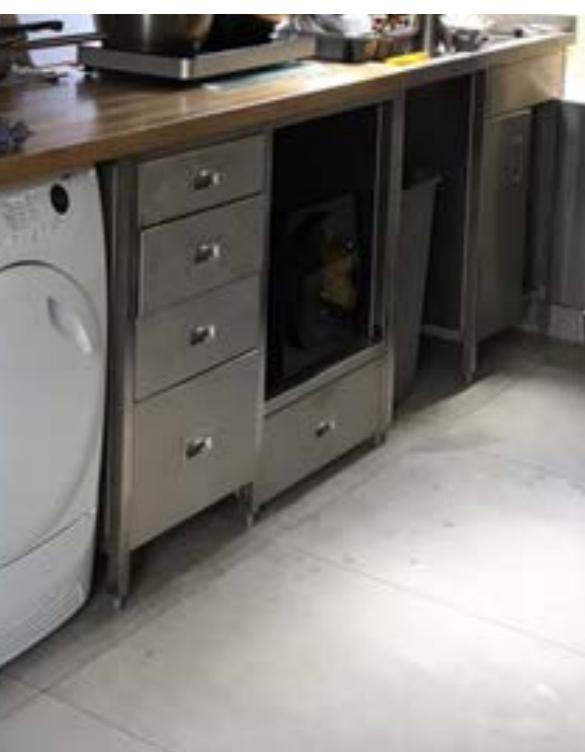
Stainless steel kitchen.

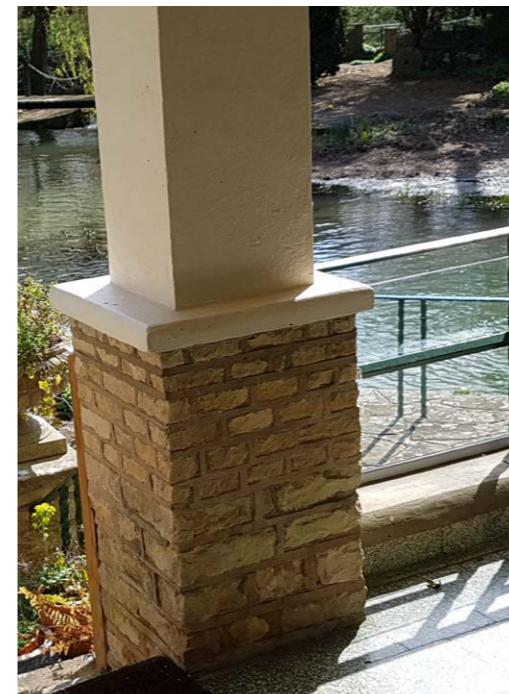
The glass barrier with floodgate for access on river-facing side.

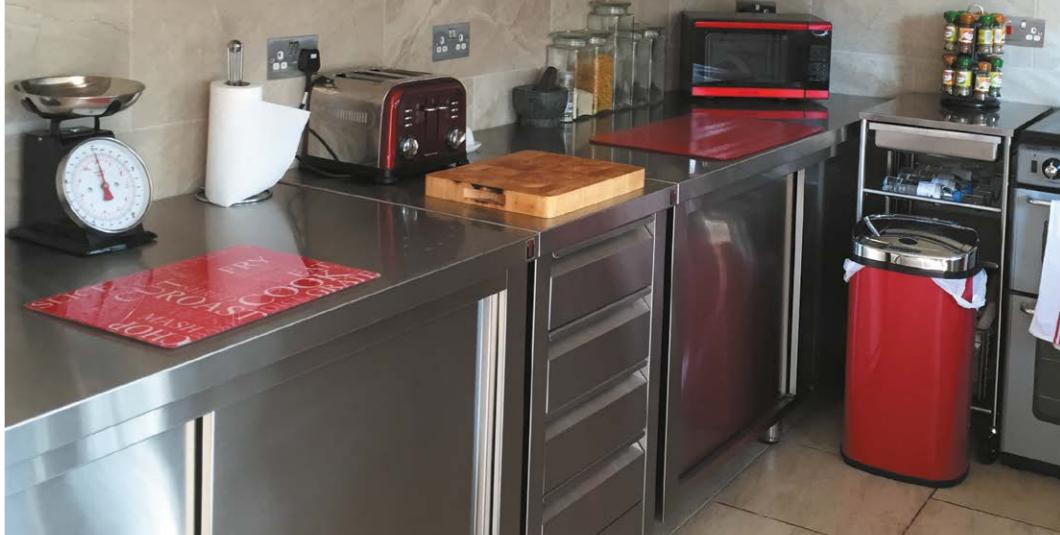
Free-standing stainless steel kitchen with free-standing appliances.

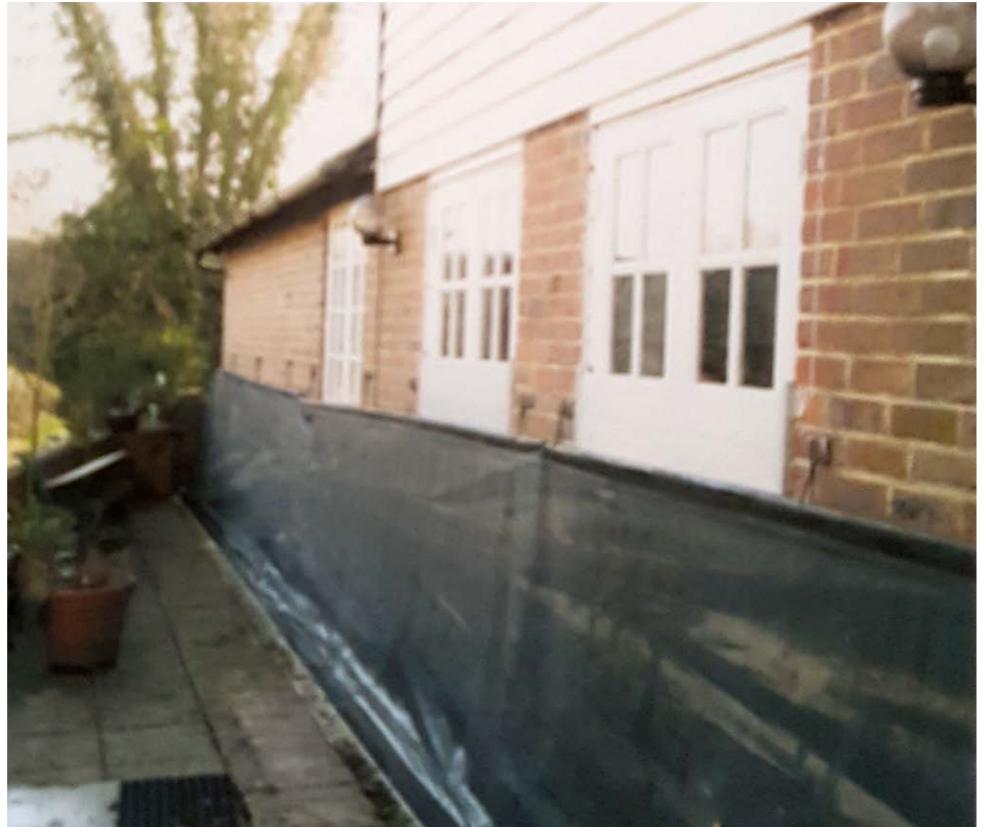
The building skirt system can be pulled up to around a metre high round the whole house when needed.

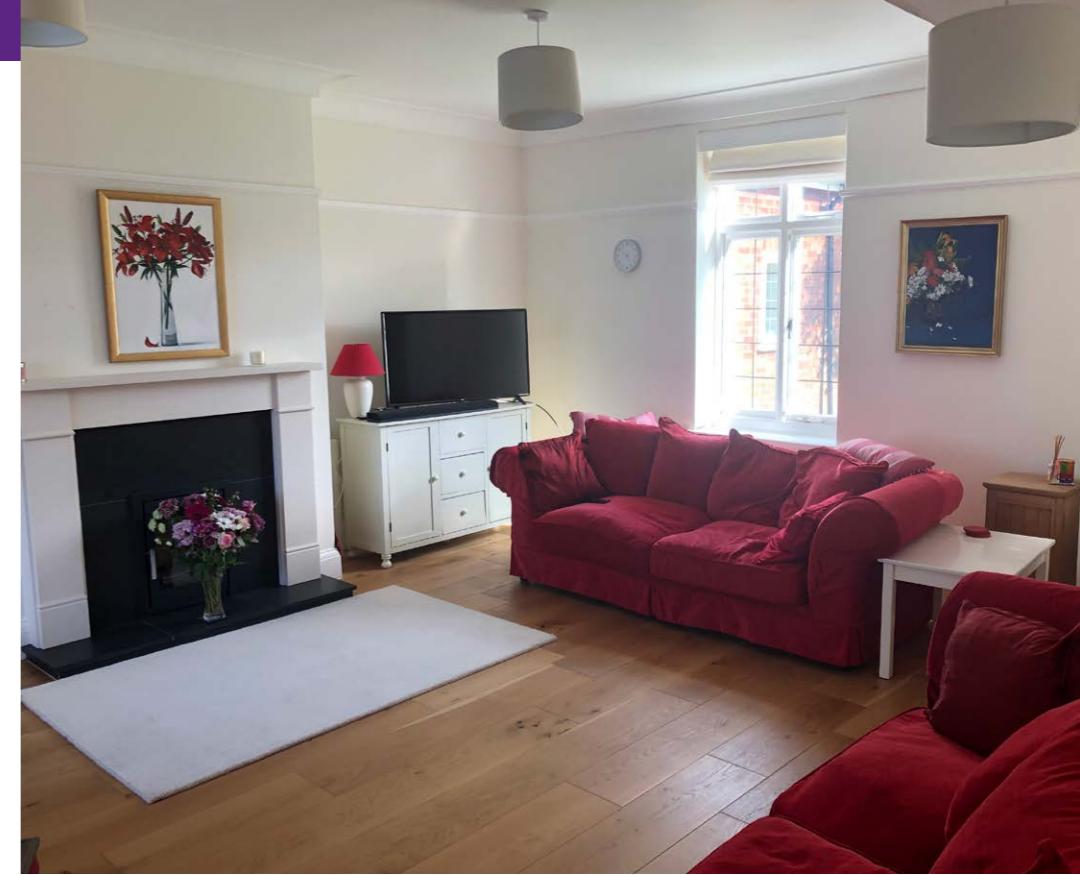
A waterproof sub floor membrane with an engineered oak floor on top.

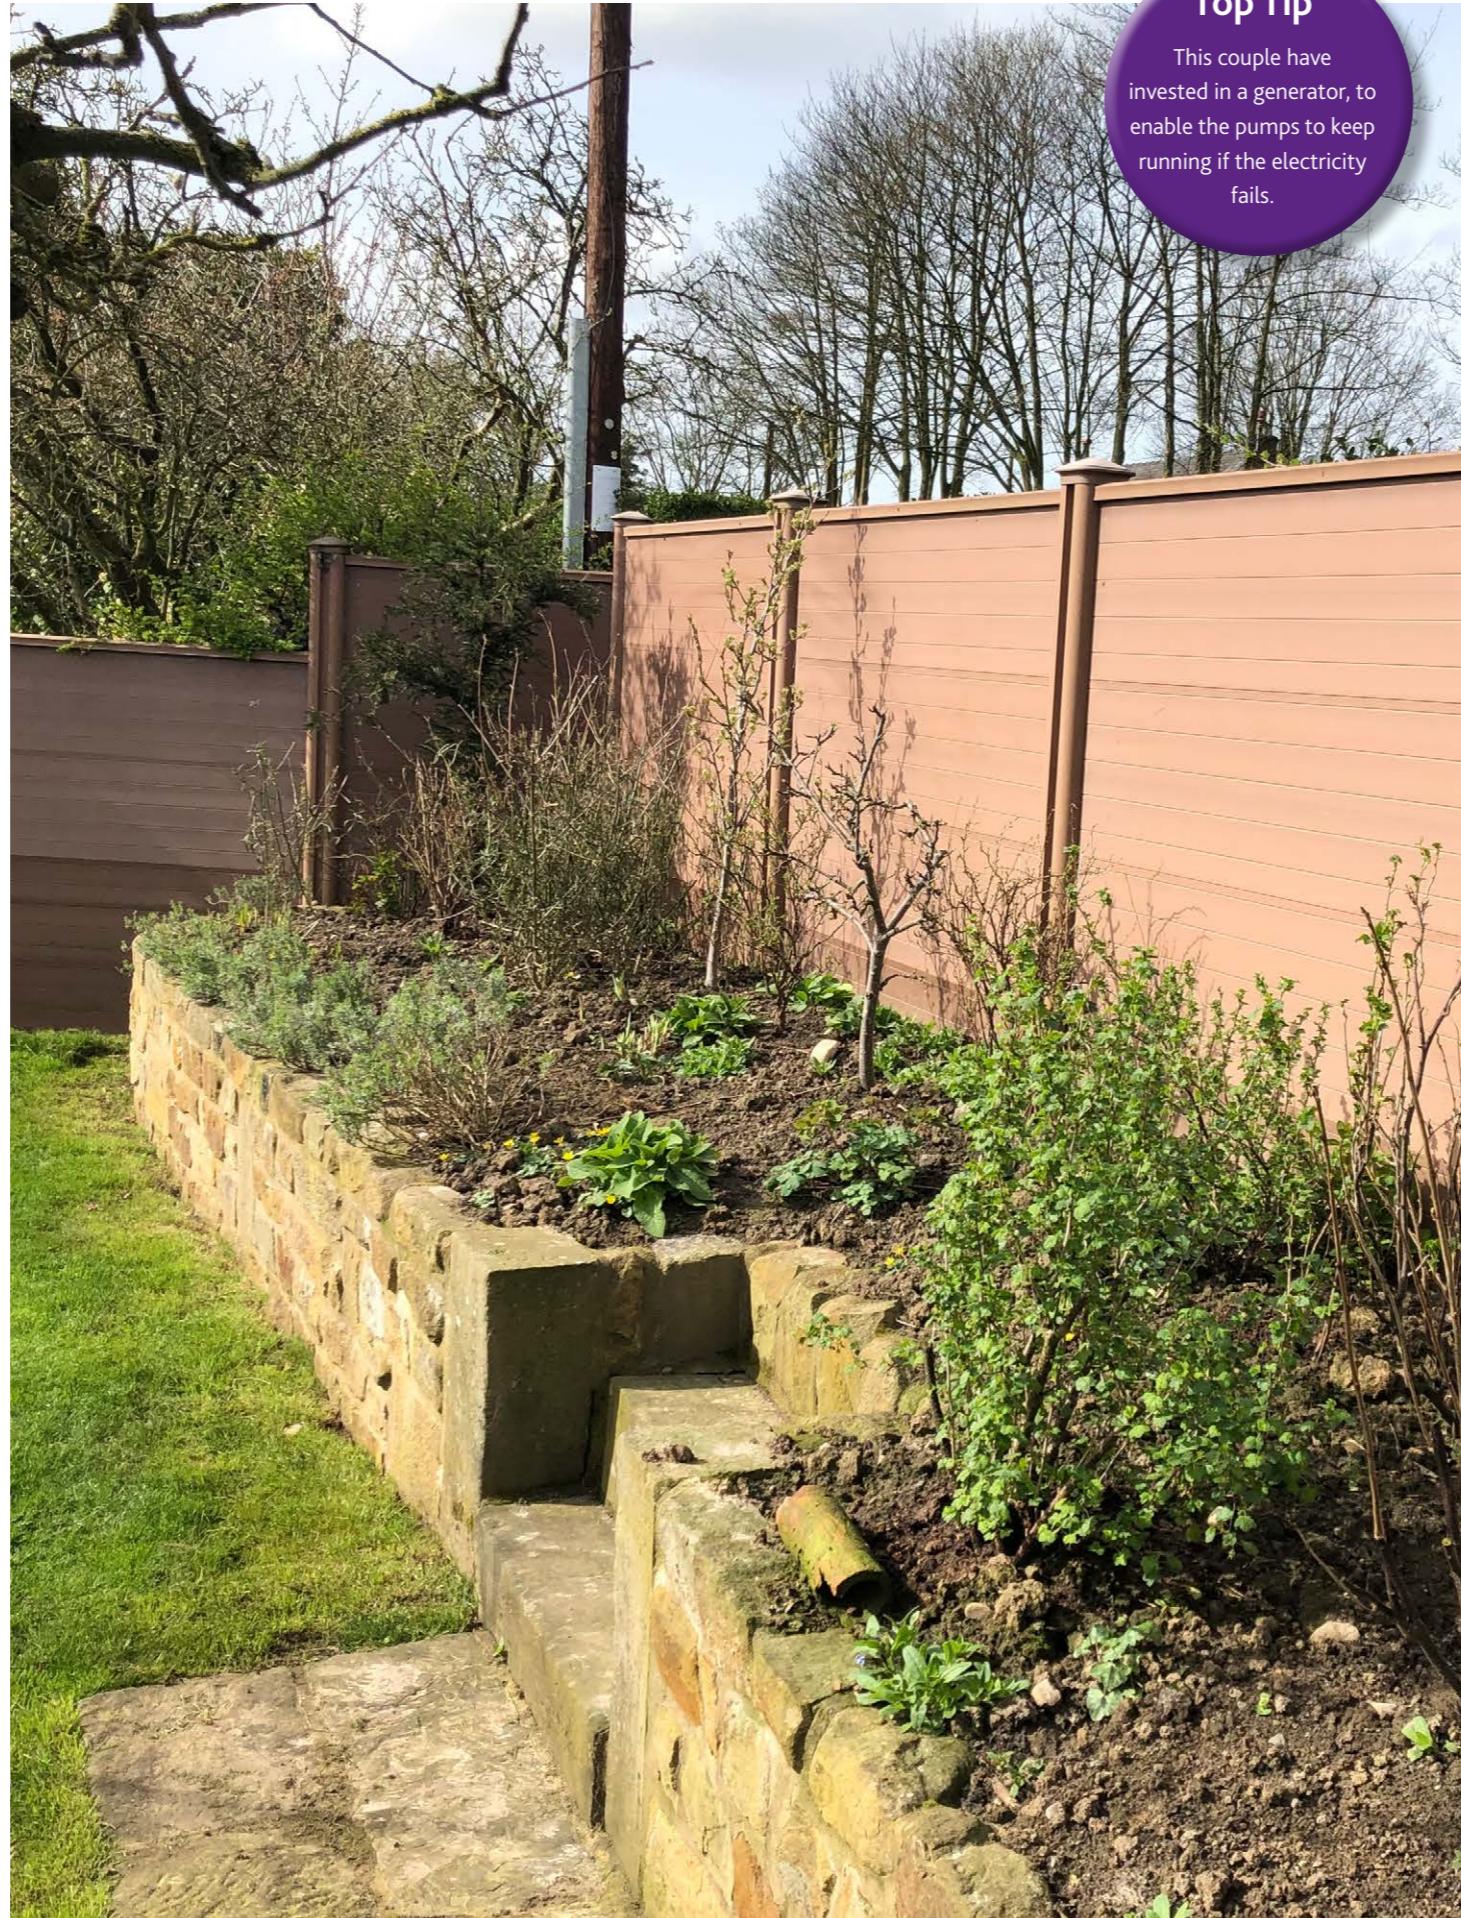
At the perimeter of the garden one-metre-deep holes were filled with concrete, into which posts and reinforced 'Task Green' waterproof fence panels were fitted.

The couple realised that unless they did something to stop the flood water from entering their home, they would be unable to sell it in the future (if they chose to), but also that they could not continue to live there with any confidence of another flood not occurring. They did a lot of research and decided to improve the internal resilience but also to invest heavily in trying to keep the water out of the garden and home. They did the following:

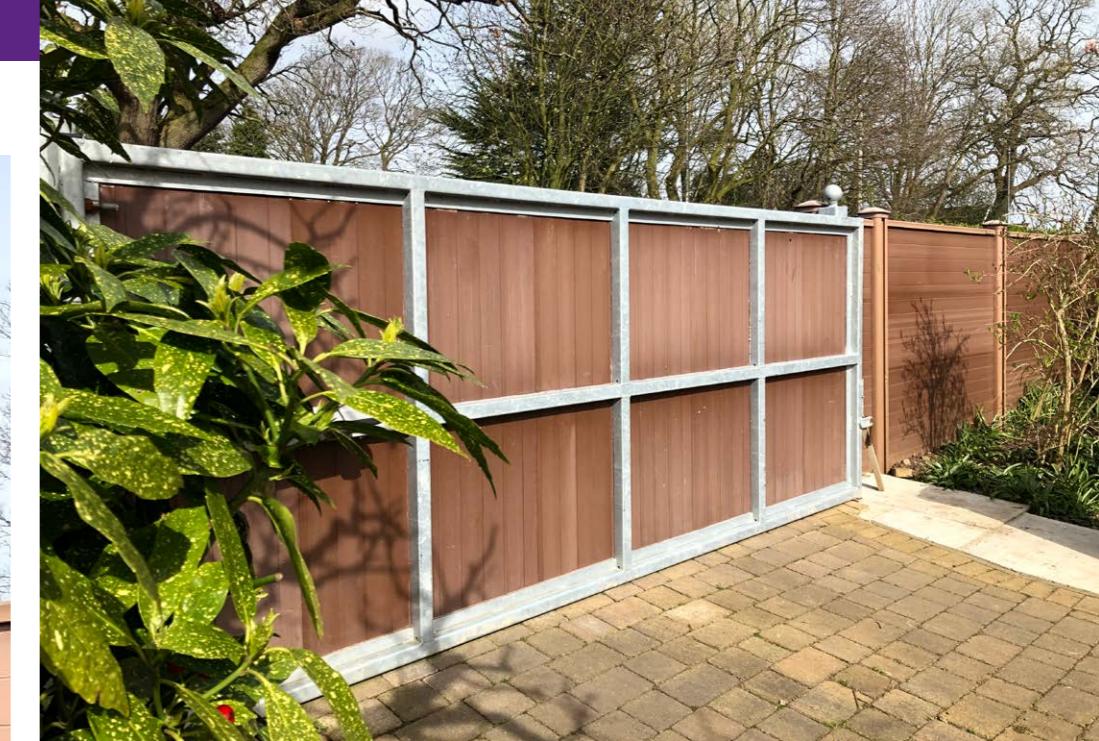
The front entrance gate is the same material as the fence panels and is fitted tightly to prevent ingress of water.

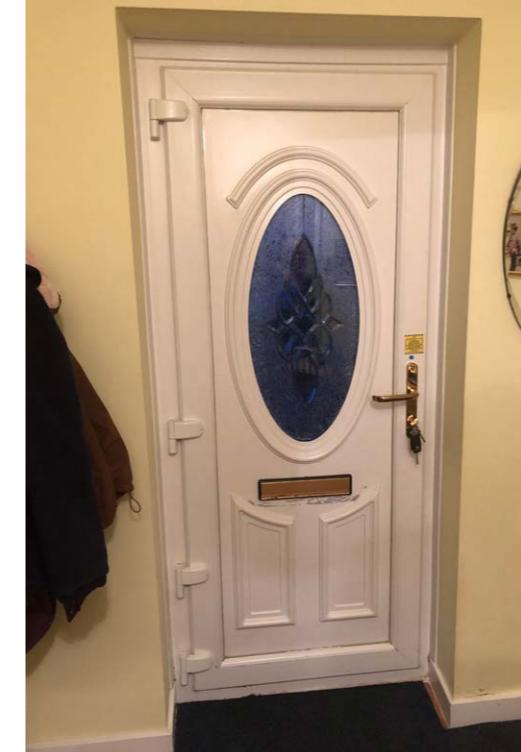
Flood resilient front door has been installed.

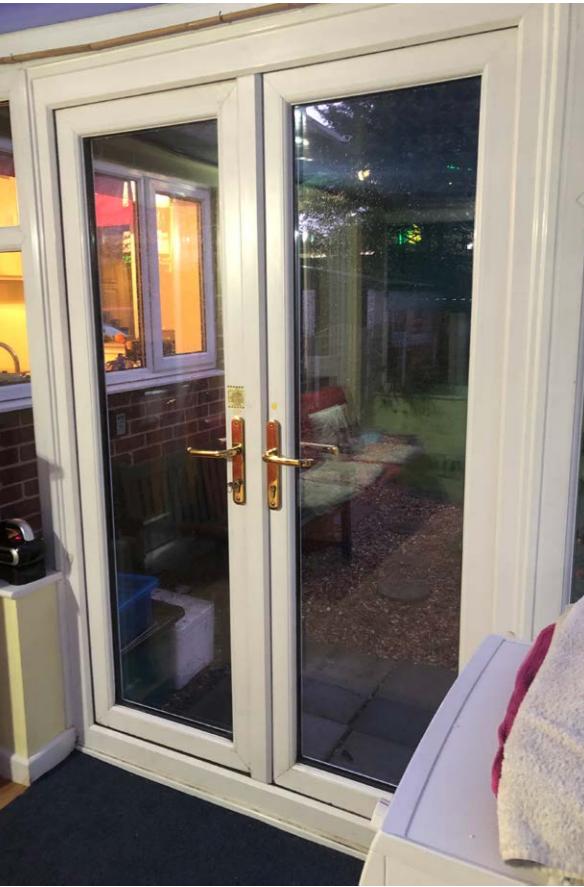
Flood resilient patio doors have been installed.

- A non-return valve in pipework, to prevent backflow.
- The sewer pipe also now has an NRV, as a dead rat was found in the kitchen following the first flood!
- The external brickwork has been sprayed with a waterproofing agent.
- Flood resilient doors have been installed throughout.
- In conjunction with a neighbour, a 'concrete type' fence has also been erected. Although they don't expect this to stop the water, the couple are hoping it will at least slow the flow down, providing extra time to get out if necessary.

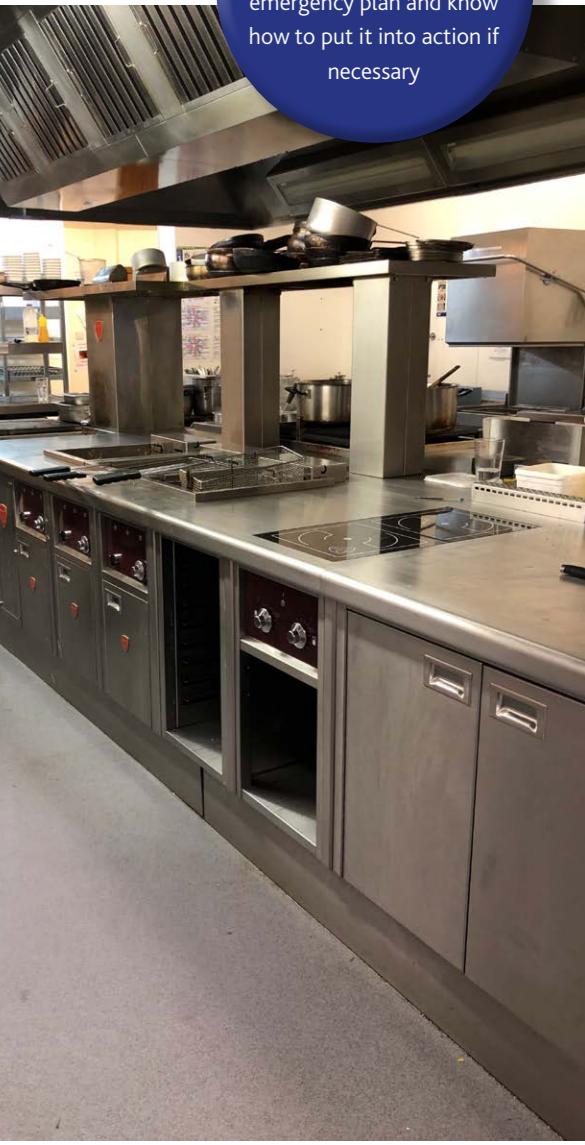
The motor can be removed from the stainless-steel kitchen 'Chave block' (cooking area).

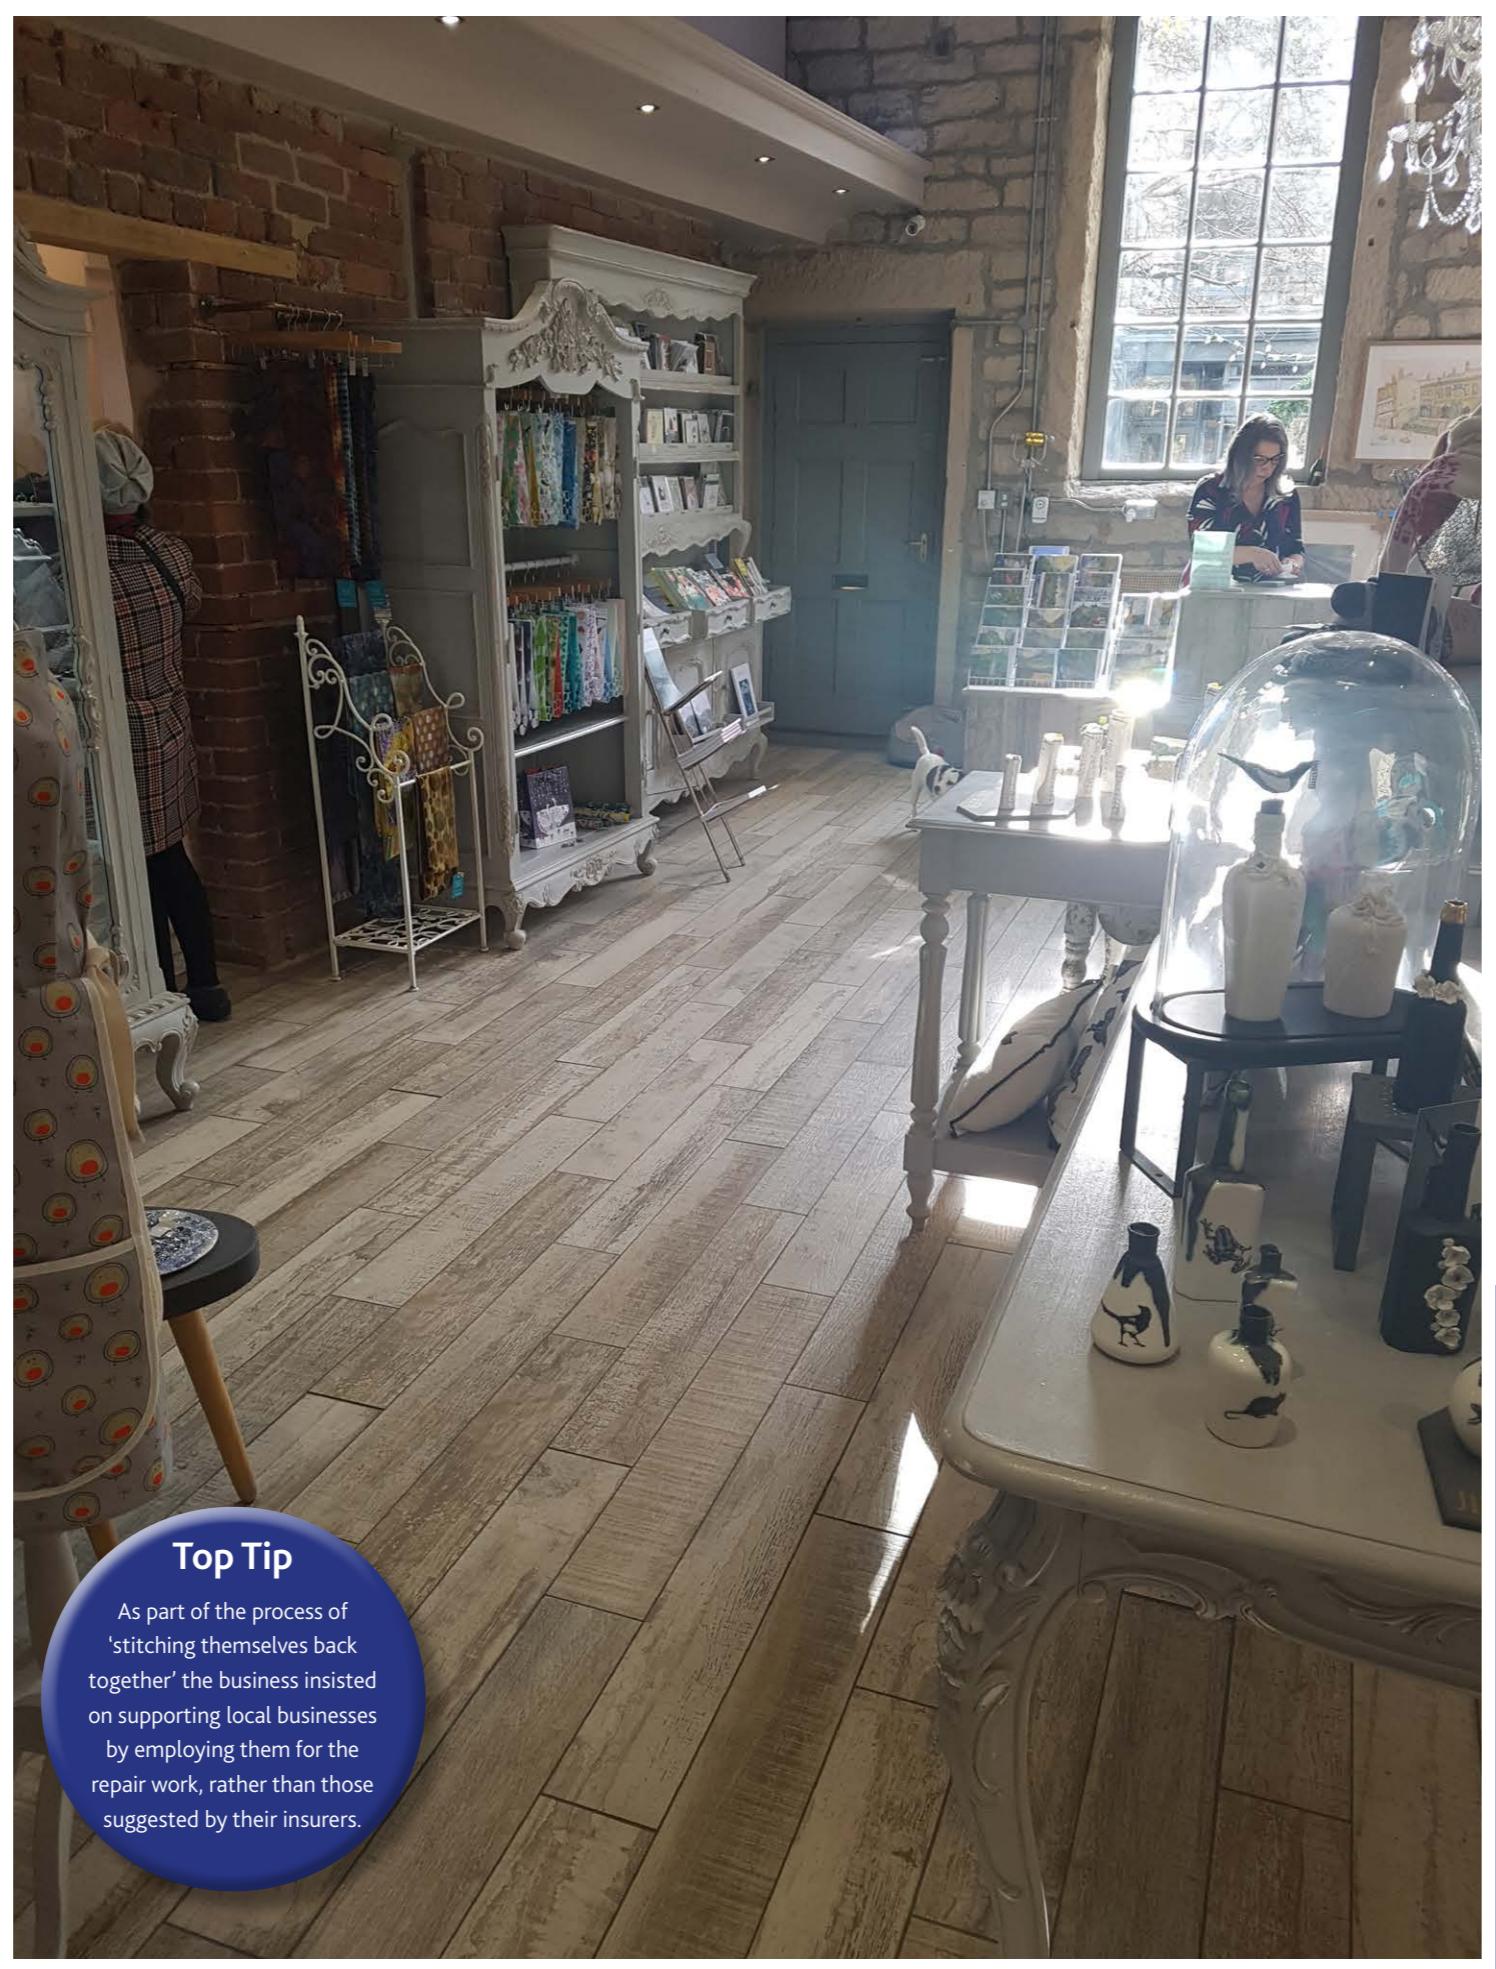
Floor surface is finished with porcelain tiles patterned to mimic floorboards.

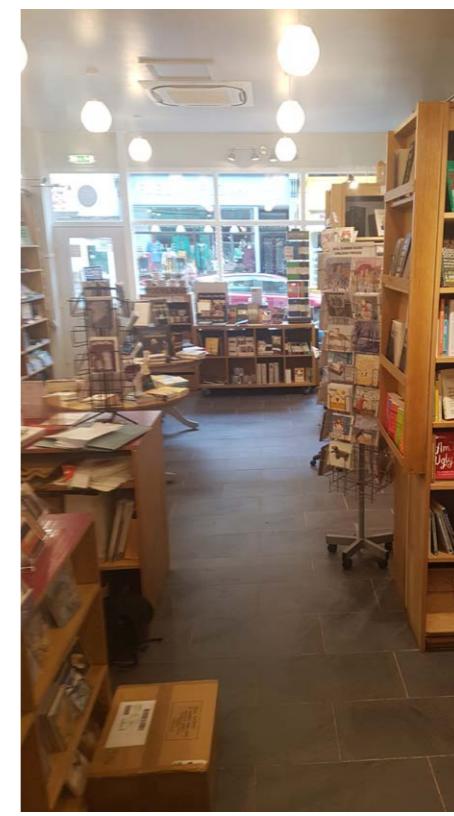
Concrete flooring, finished with composite tiles.
