Property Flood Resilience

Stories from homes and businesses who have made adaptations
to help them recover more quickly after a flood

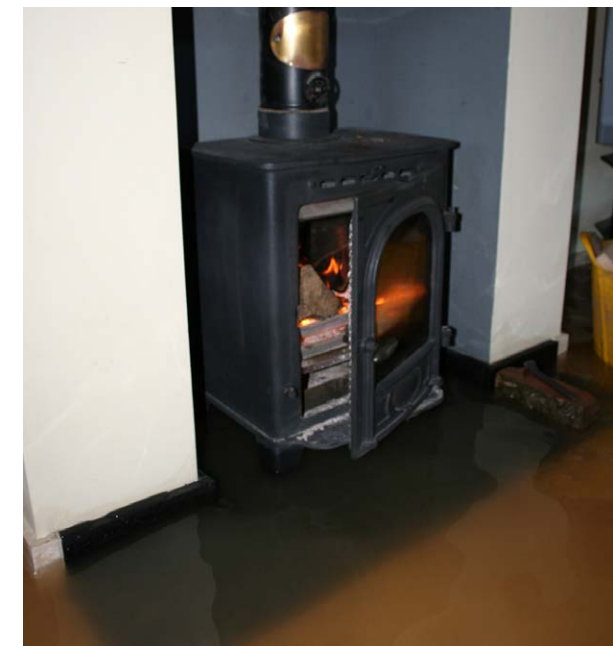
Immediately light the log burning stoves helps start the drying process and reduces the time it takes to recover.

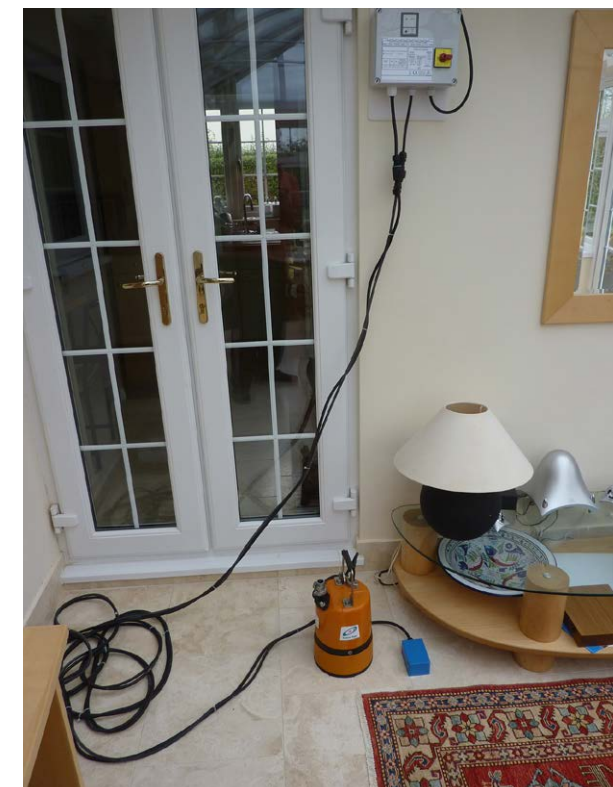
Electrics installed up high, which come down from the floor above, enabling them to run powerful puddle pumps.

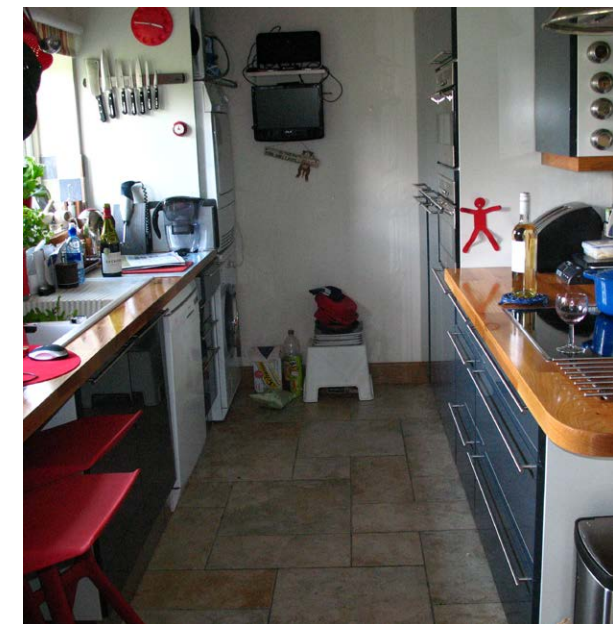
New boiler raised above floor with inbuilt cupboard underneath.

- New boiler raised to 76cm (2'6") above floor with inbuilt cupboard underneath. Jagged central heating radiators with Low-H2O technology containing 90% less water than steel panel radiators were installed. The front panels can be removed and placed upstairs and internal 'fins' are waterproof.
- Impermeable porcelain tiles were laid throughout the ground floor.
- Two original mediaeval oak doors on the ground floor were replaced in solid oak – sad but necessary.
- Kitchen units were fitted with powder-coated steel carcasses with solid acrylic doors/draw fronts.
- A wall mounted microwave and oven were fitted.

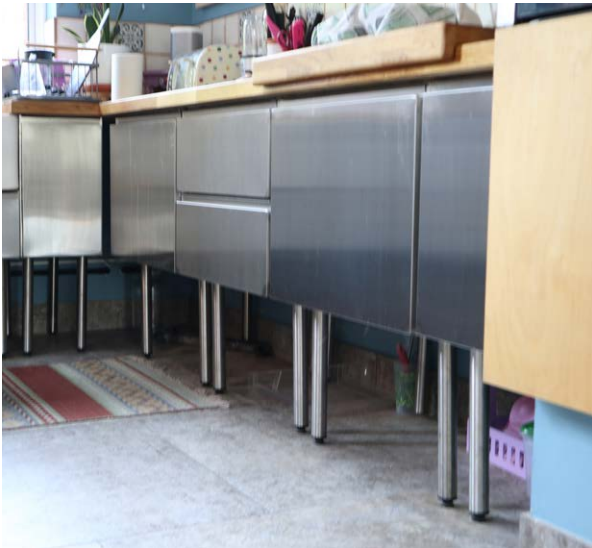
The floor is raised by around 23cm (9").

- Continues to use the slot-in flood barriers.
- Knocked two rooms into one and concreted the floor, raising it by around 20cm (9").
- The floor was tiled using porcelain tiles with waterproof grout and adhesive, and the skirting boards were tiled around.
- Two submersible pumps were fitted; one to the front of her house and one to the back in the kitchen.
- Waterproof plaster to the walls.
- The first four steps to the upstairs staircase are now made of stone.
- A stainless-steel kitchen was fitted with the base units raised above floor level.
- White goods are sited higher up in an enclosed cupboard.
- A small dishwasher is raised up off the floor.
- Living room storage cupboards are made of metal.

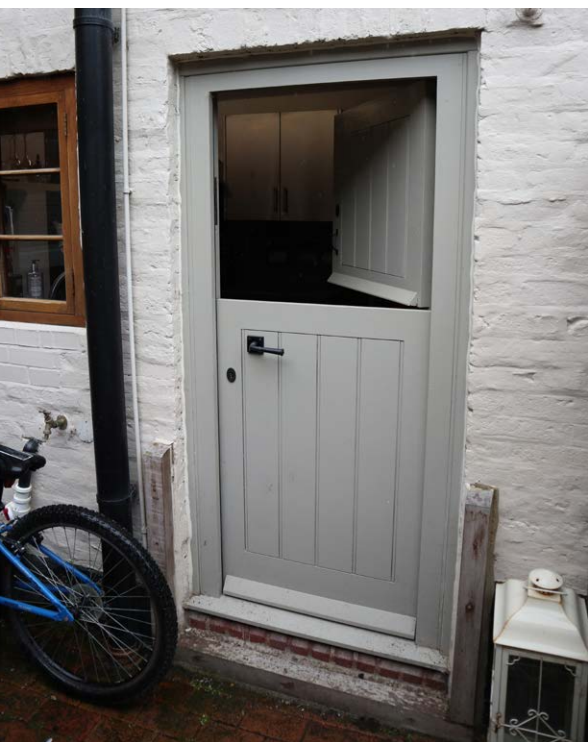
Flood doors, which are approved for listed buildings.

- Fitted two flood doors, which are approved for listed buildings (funded by the Environment Agency). Both doors leaked from underneath, so were sealed with silicone sealant, which stopped water from entering. They have now been refitted to work properly. The new Code of Practice recommends a 'wet test' is undertaken to test for any leakage straight after installation, do insist this takes place.

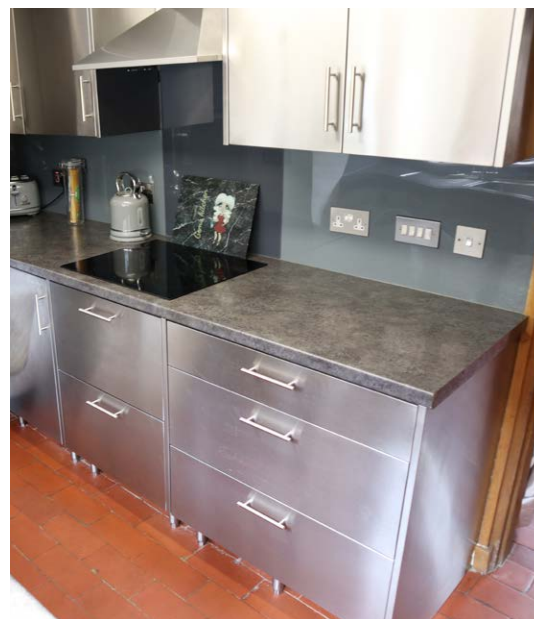
Stainless-steel kitchen and solid floor with quarry tiles.

- Solid floor with quarry tiles.
- Cement render to the walls.
- Plug sockets are raised.
- Fitted plastic skirting boards.
- Non return valves to outlet pipes.
- Three powerful puddle pumps.
- A grant part-funded a stainless-steel kitchen.

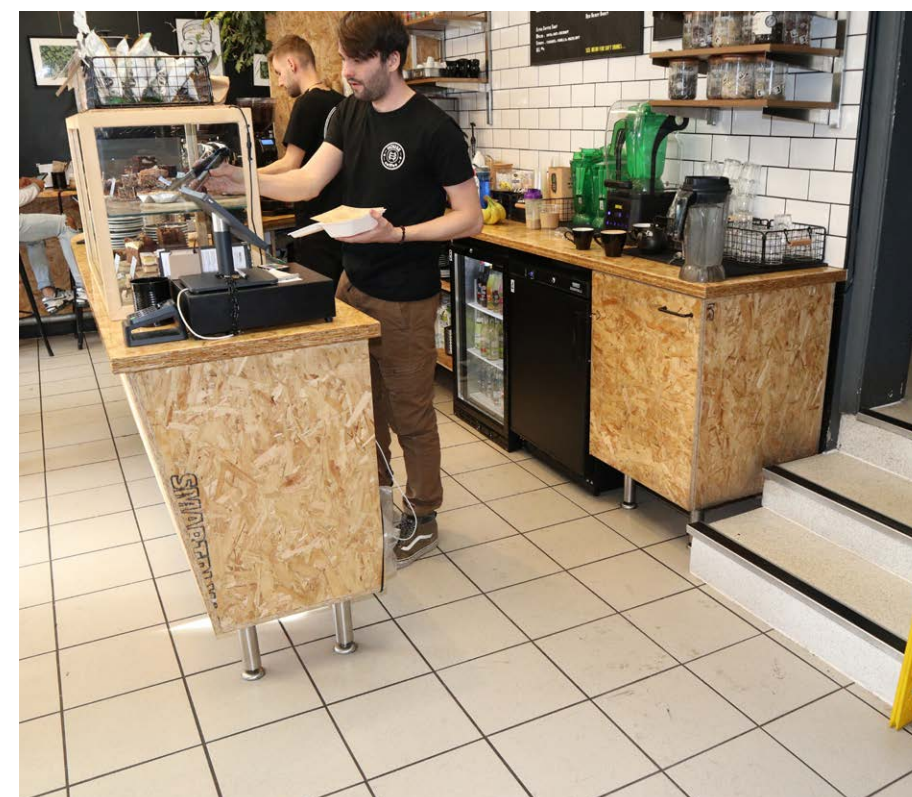
The shop counter is made of an inexpensive material with stainless-steel legs, which can be easily moved.

- Acquiring tables and chairs with metal legs.
- The shop counter is made of an inexpensive material and has high stainless-steel legs, which can be easily dismantled and moved if a significant flood is expected.
- Tiled flooring, which can be easily washed down and sanitised.
- After drying the original plaster, OSB boarding has been added, which is an engineered wood which is fairly water resistant. The OSB boarding is pinned to the wall, so it can easily be removed and replaced and allows the walls behind to dry out if needed. It also gives the coffee shop an 'industrial chic' look and looks totally deliberate.
- Using a government grant, the couple now have kitemarked flood barriers to both doors and submersible pumps just inside the doors, which pump away any ground water or any flood water that has got into the shop.

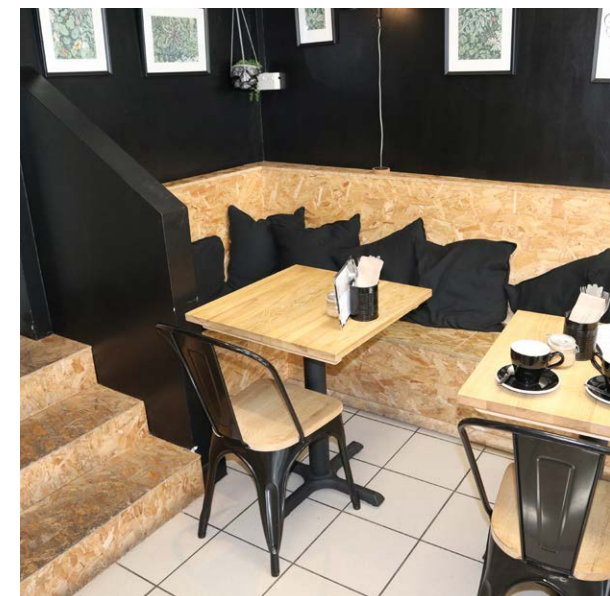
OSB boarding pinned to the wall can easily be removed and replaced to allow the walls behind to dry out.

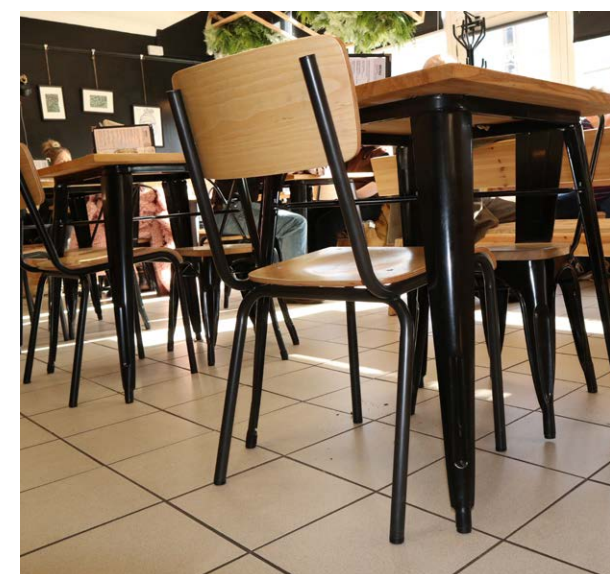
Tables and chairs have metal legs and the tiled flooring can be easily and sanitised.

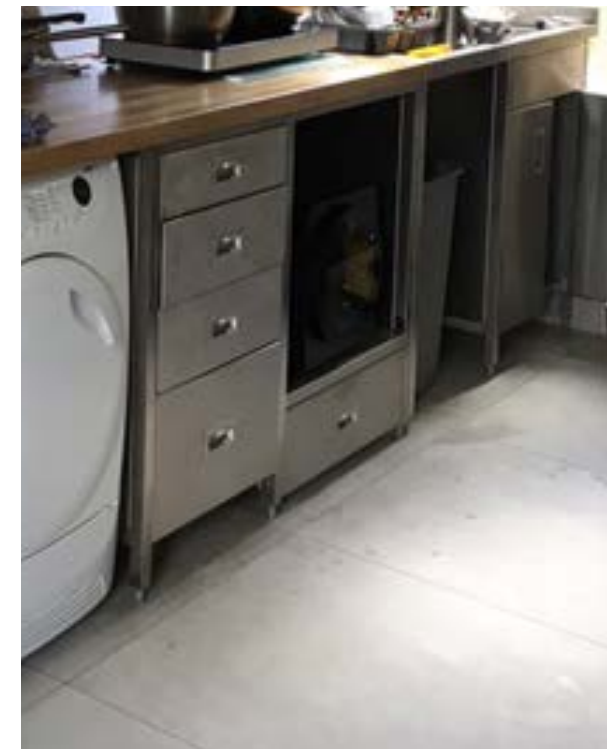
Stainless steel kitchen.

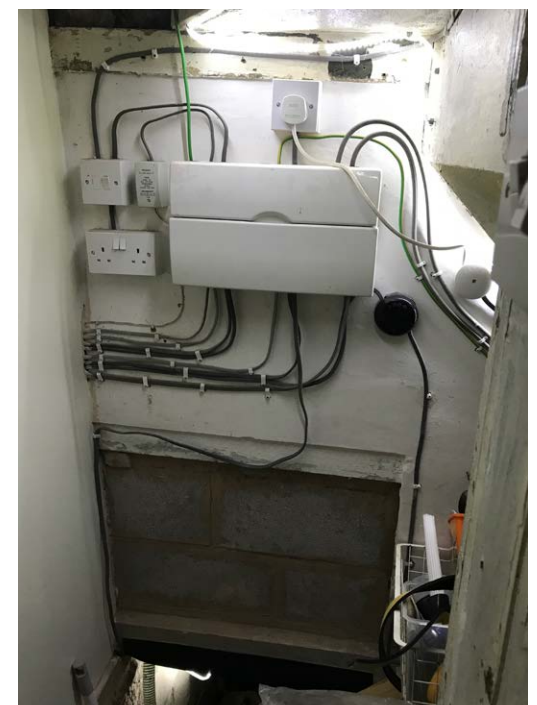
The consumer unit fuse box is still in the cellar but is 1.5m (almost 5') above the floor level.

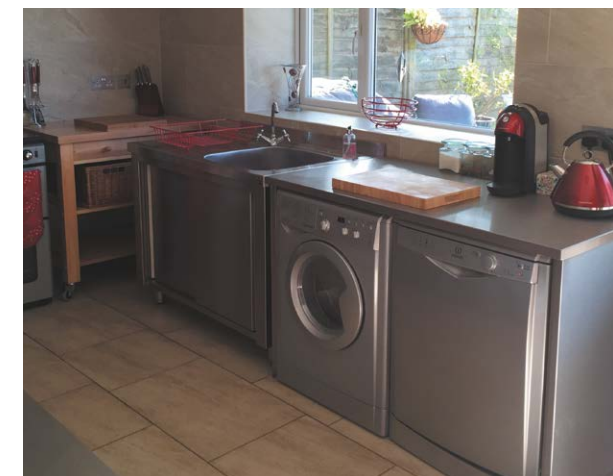
Recoverable measures included:

- Free-standing stainless steel kitchen with free-standing appliances, which can be moved to safety. The walls are tiled from floor to ceiling, using water-resistant cement and grout; internal door re-hung with hinges allowing it to be lifted off and moved upstairs.
- The ground floor is tiled throughout, using water resistant cement and grout – it can be hosed down and disinfected after a flood.
- The window sills are made of hardwood instead of the usual easily-damaged softwood.
- The fireplace surround is also made from hardwood, and has successfully survived a flood.
- A flood-resistant door has been installed, which allows additional time for moving items before the water has to be let in.

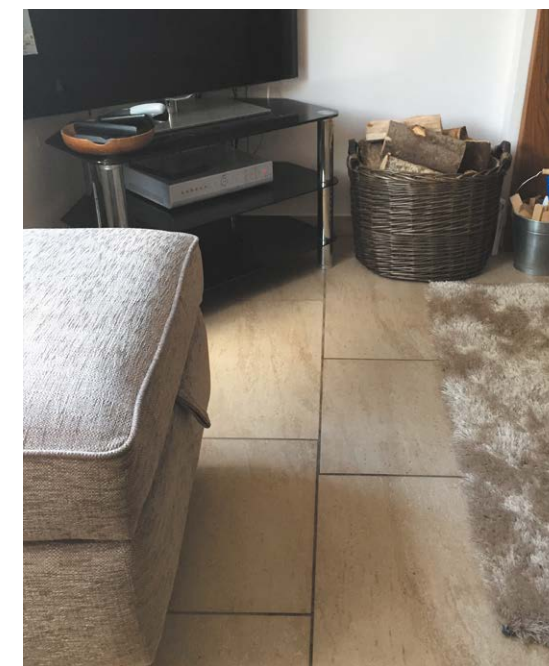
The ground floor is tiled throughout, using water resistant cement and grout

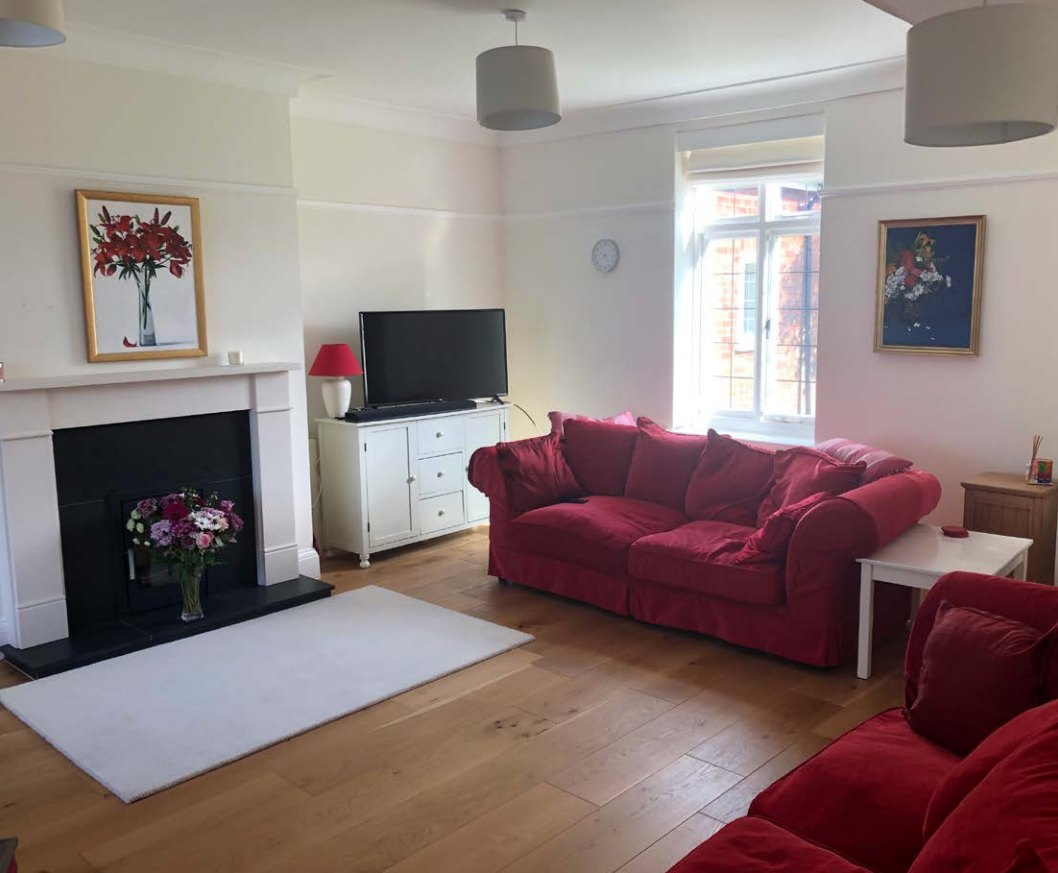
A waterproof sub floor membrane with an engineered oak floor on top.

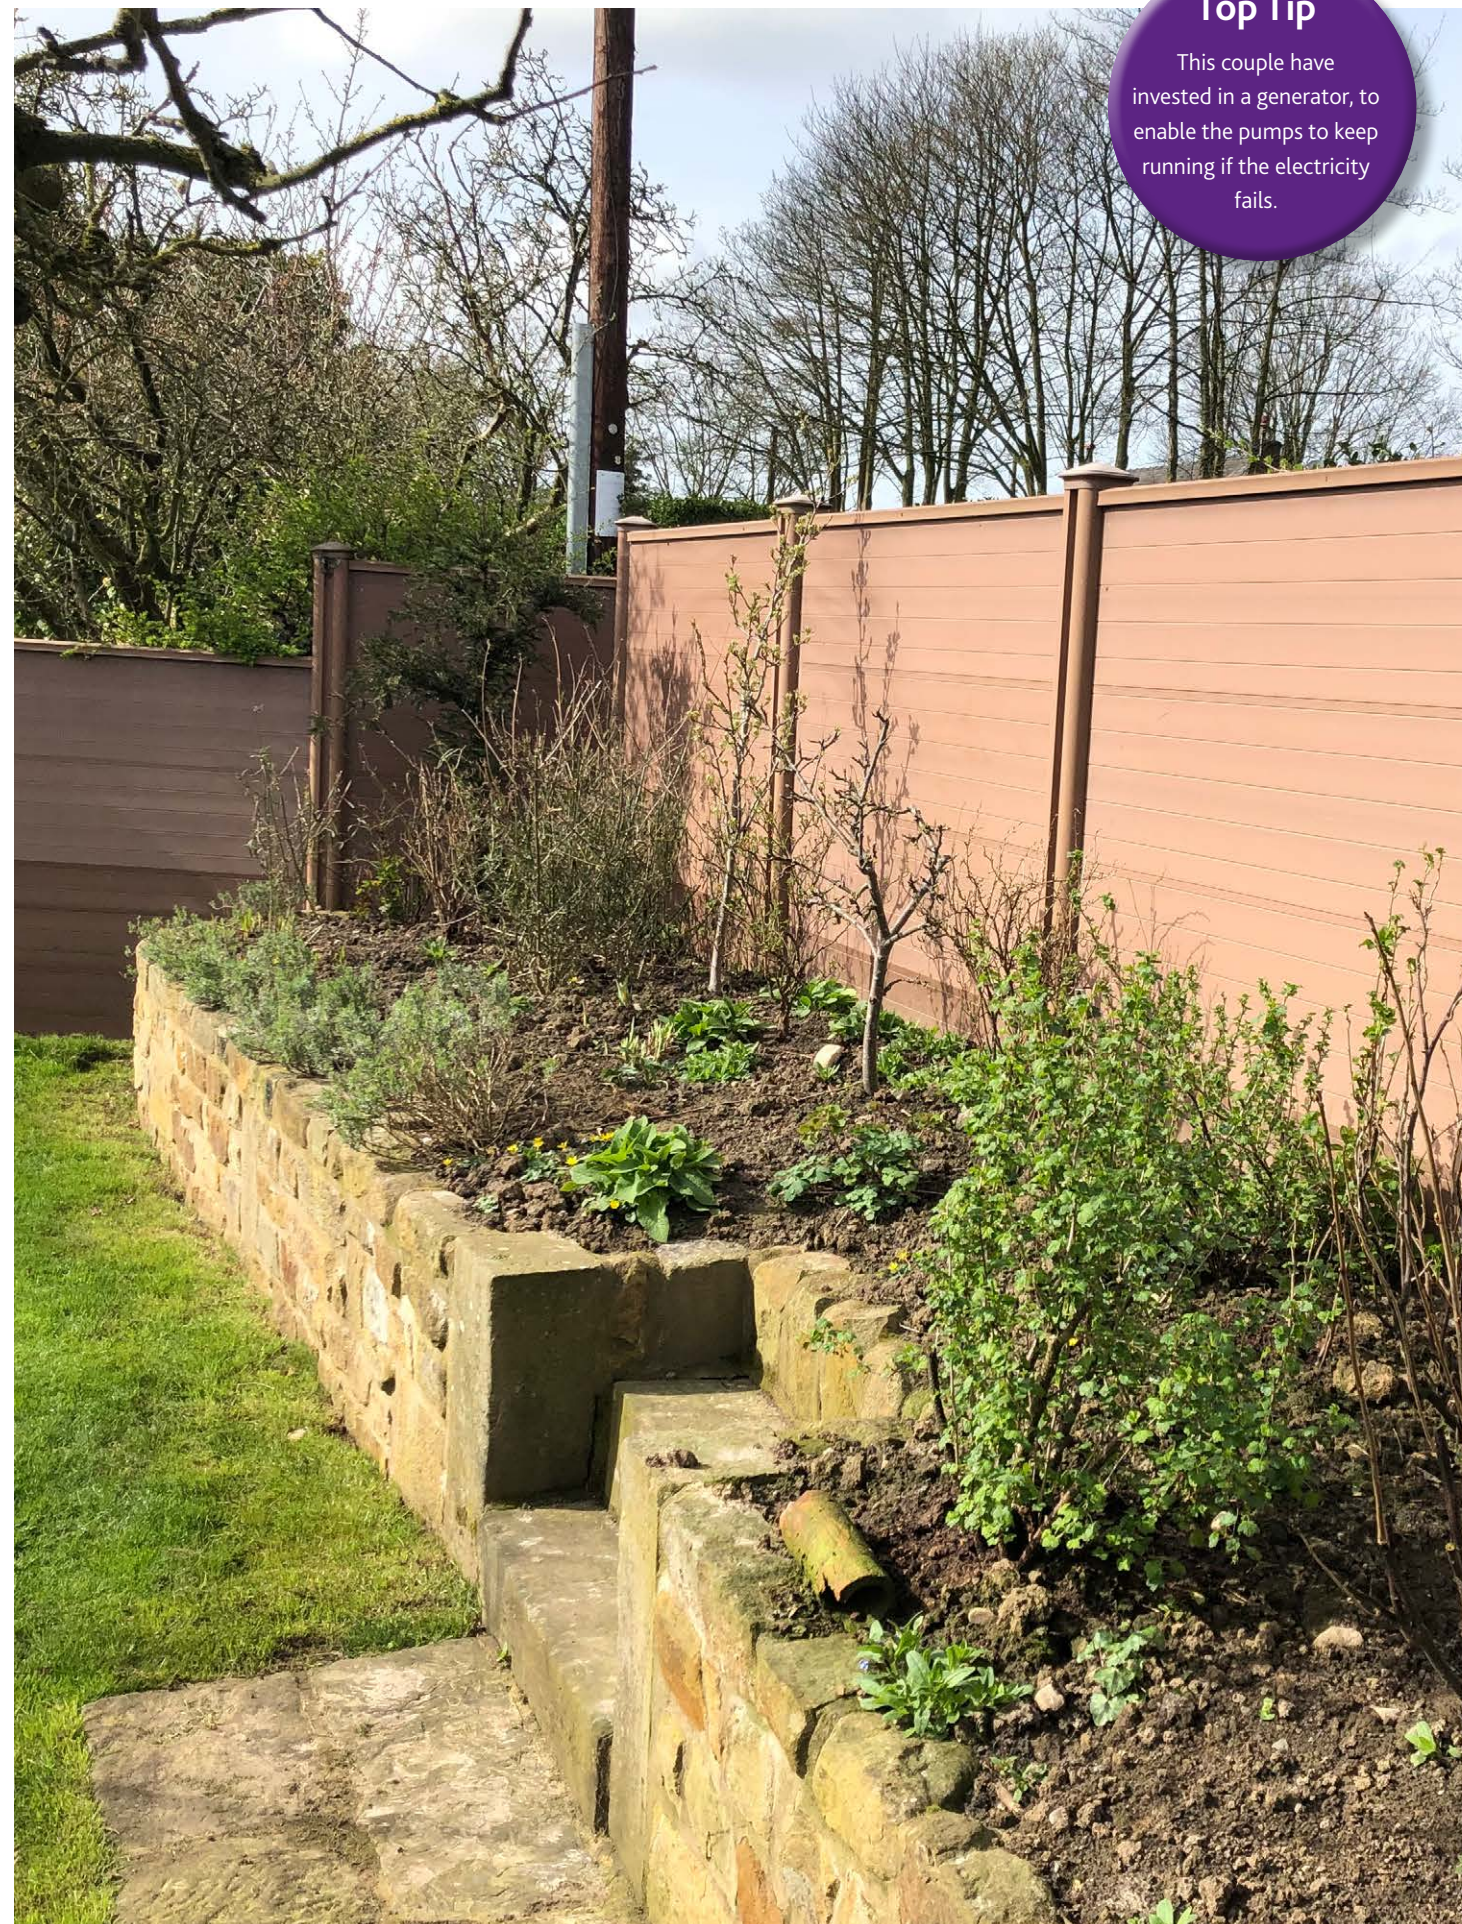
At the perimeter of the garden one-metre-deep holes were filled with concrete, into which posts and reinforced 'Task Green' waterproof fence panels were fitted.

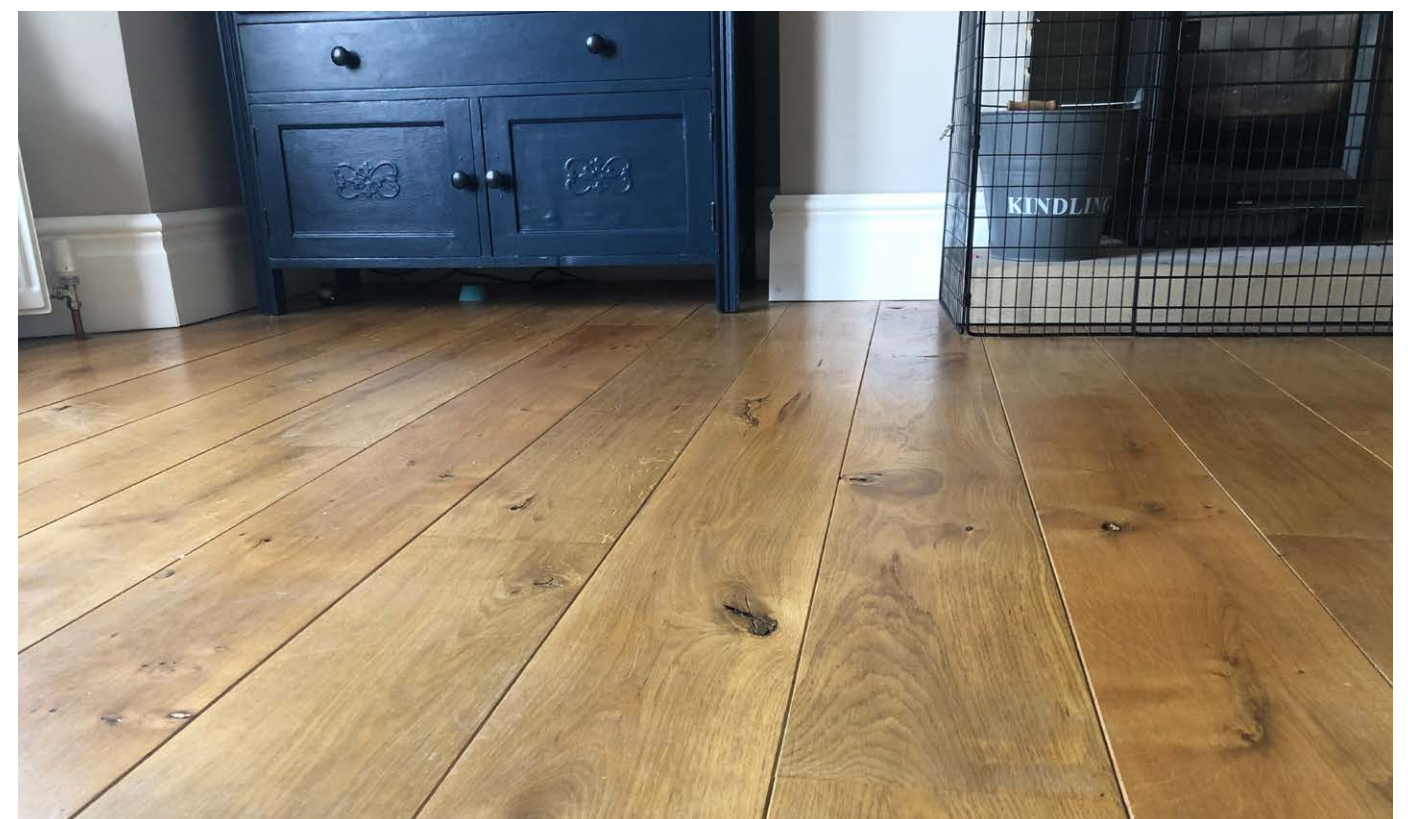
Hard wood flooring with rugs replace the carpets which were a nightmare to lift out and dry following the flood.

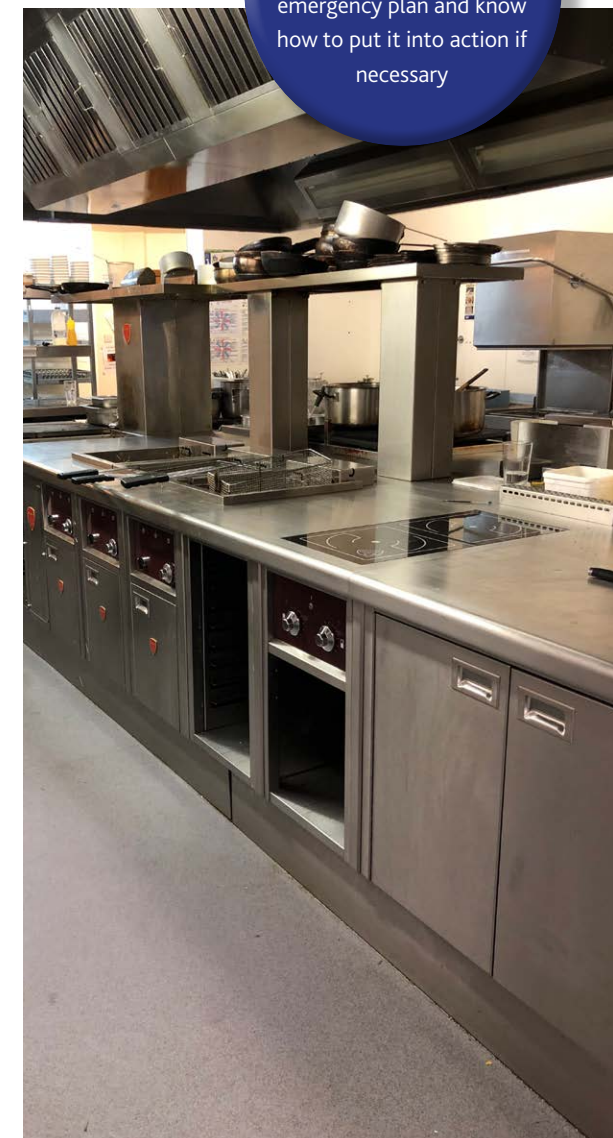
The motor can be removed from the stainless-steel kitchen 'Chave block' (cooking area).

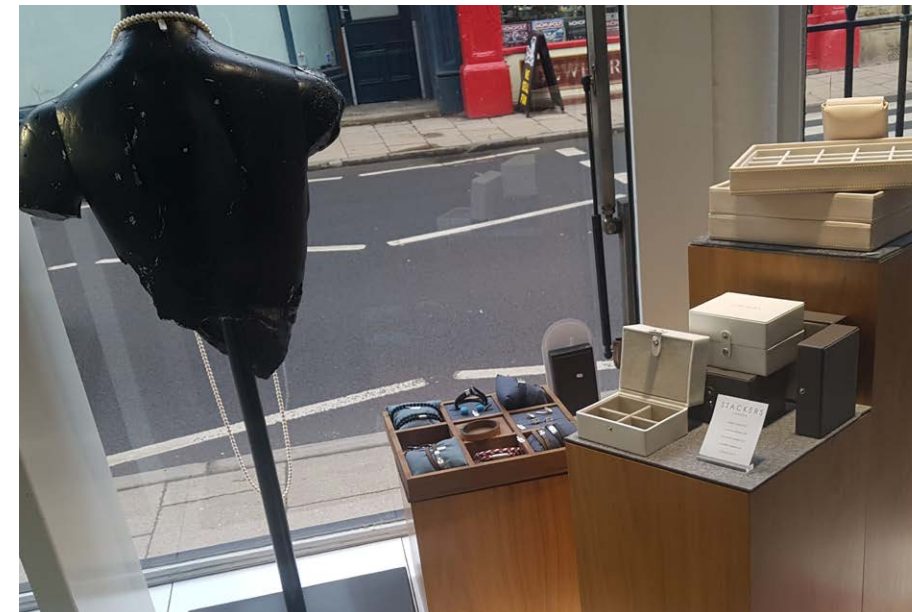
The display windows have bracing that can be lowered when needed, to protect the glass from water pressure.

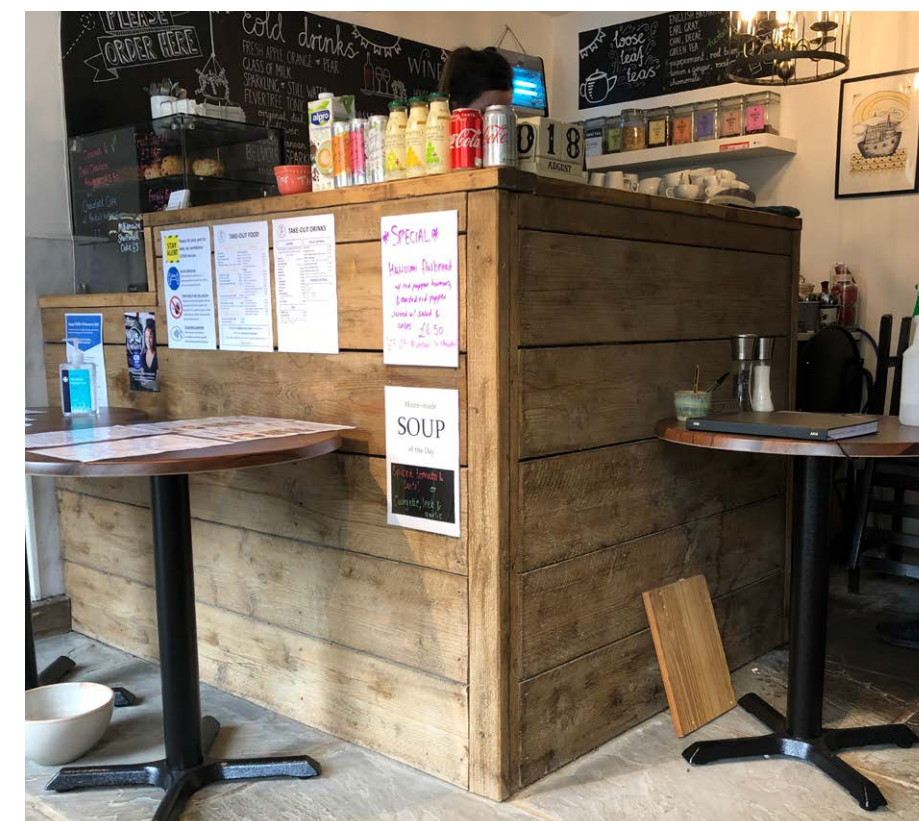
Main counter made of varnished scaffolding planks.

- Laid a stone floor using waterproof grout and adhesive.
- Installed thick wooden skirting boards and gave them several coats of varnish.
- Fitted a new main counter, which is made of varnished scaffolding planks.
- Some walls are stone and can be washed down after any future flood.

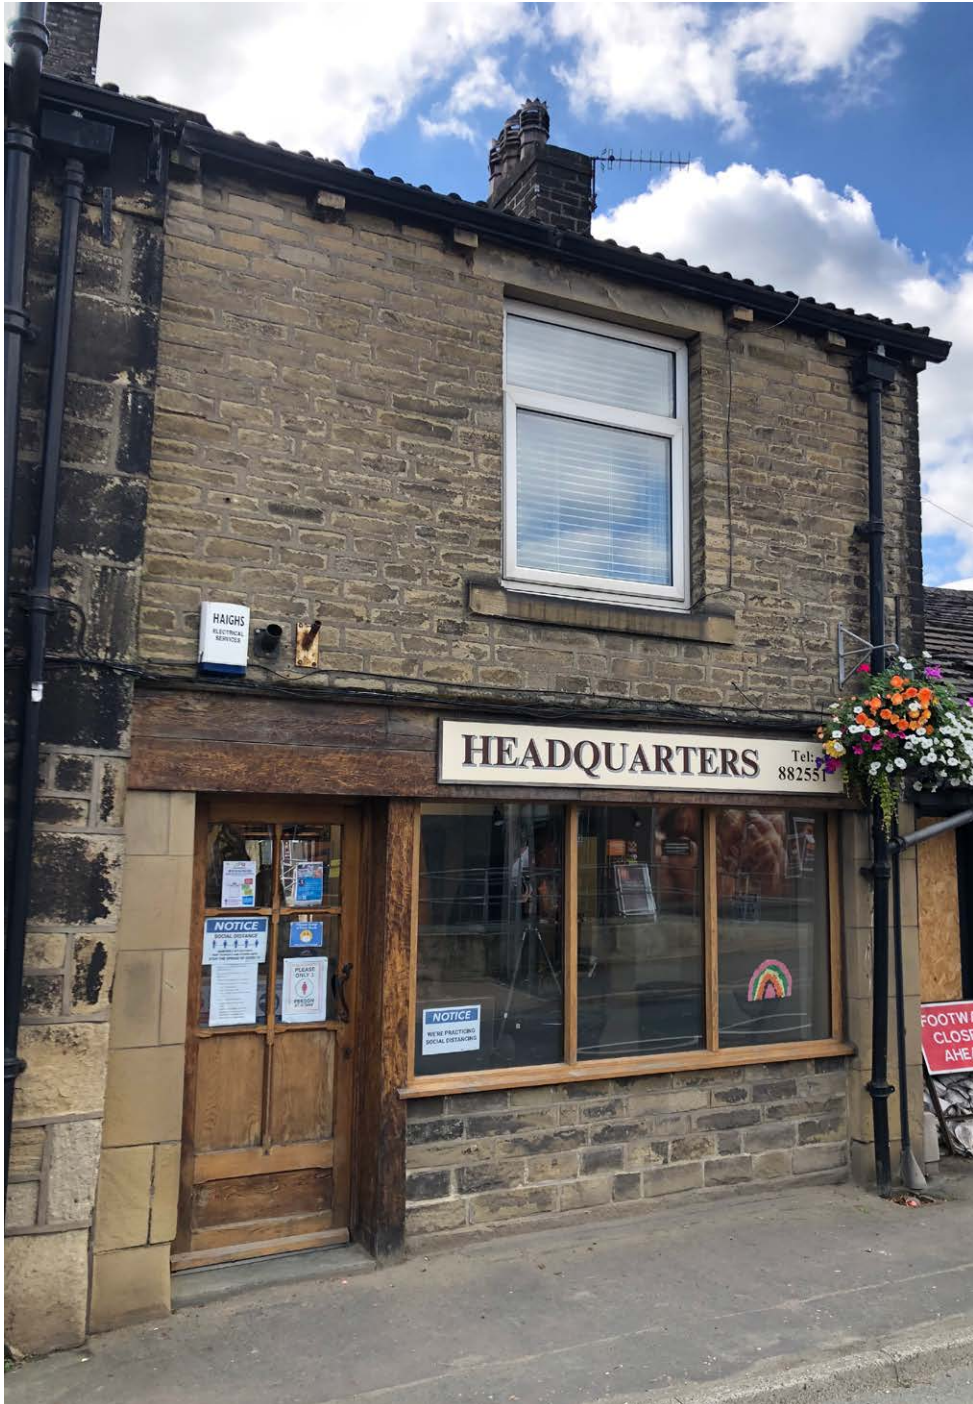
The pressure of the flood water inside caused the windows to blow outwards when the flood receded.

The pressure from this caused the windows to blow outwards. Sue says she was incredibly lucky, as a nearby hairdressers that had not flooded, allowed her to run her business from there. Had she not been able to do that, she would have had no income for the 9 months it took to repair her salon. The insurance bill was about £30,000 and sadly after this flood, Sue was unable to obtain any flood insurance.

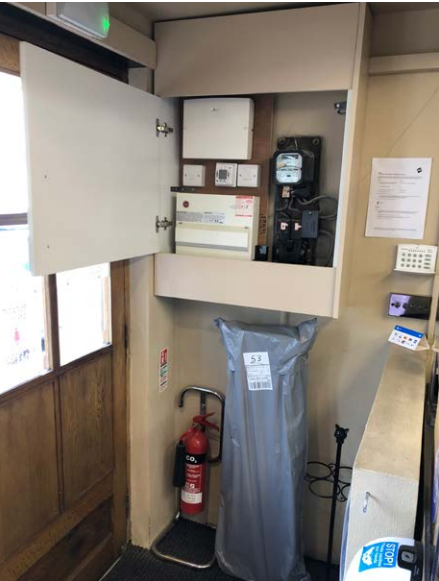
Electric meter and fuse box sited high up.
